All In One Inspections

*** Residential Inspection Report ***

July 3, 2017

123 Main Street
Windermere, FL 34786

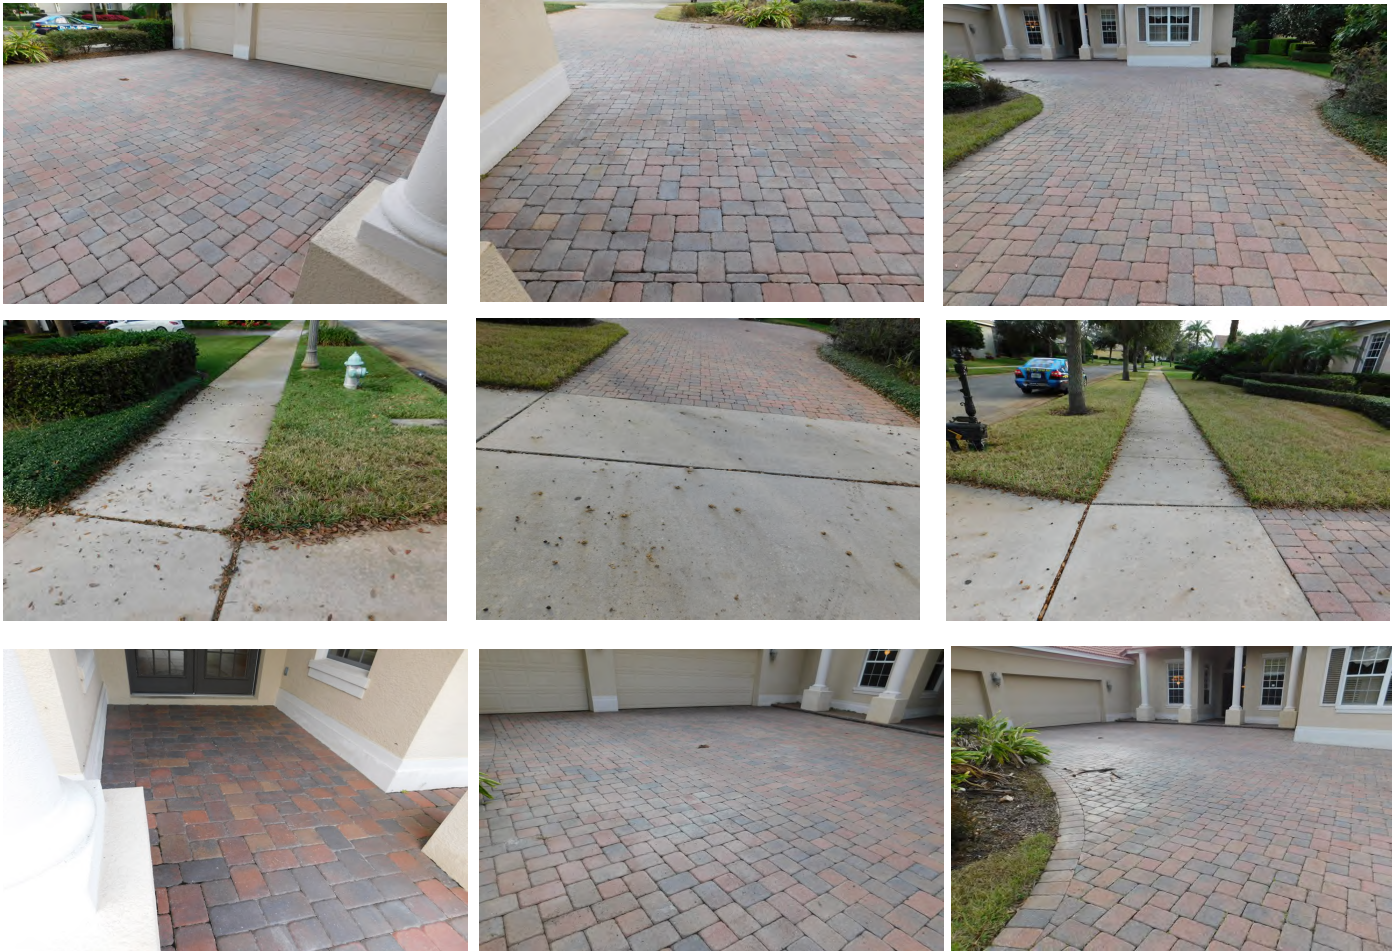
Material: Concrete and pavers
Further Comments: Concrete settling cracks noted. Maintenance is needed.

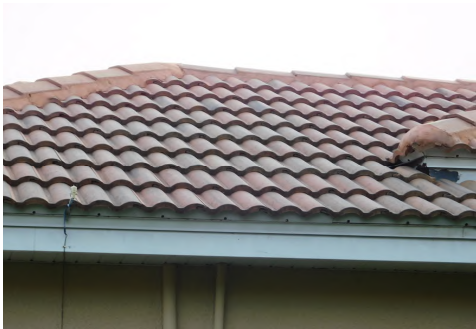
Material: Tile
Viewed from: From the ground
Further Comments: 2+ tiles need repair.

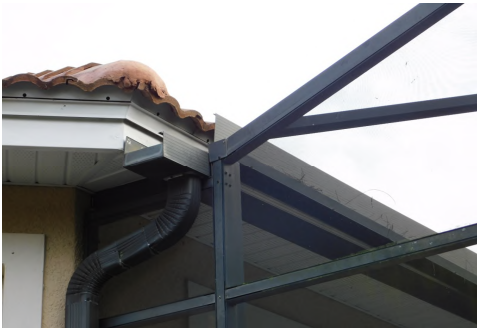
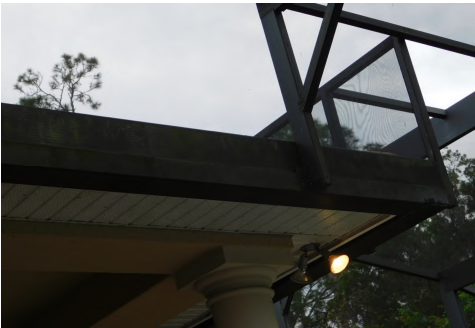
Further Comments: Recommend getting additional gutters. Gutters are in the rear only. Maintenance and resealing are needed.

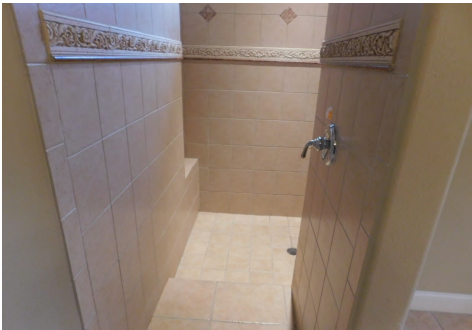
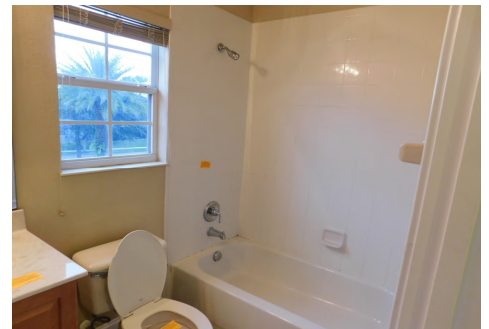
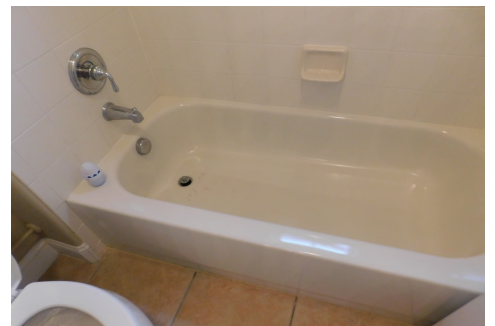
Further Comments: Showers and tub surrounds need to be sealed.

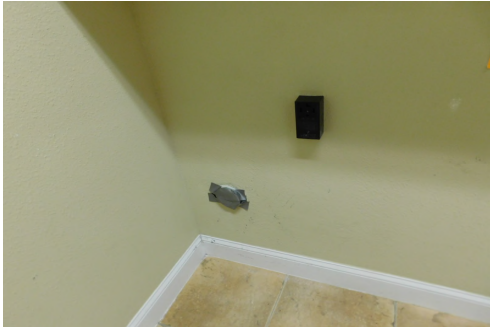
Clean dryer vent.

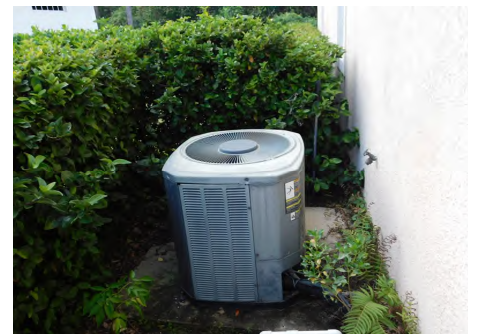
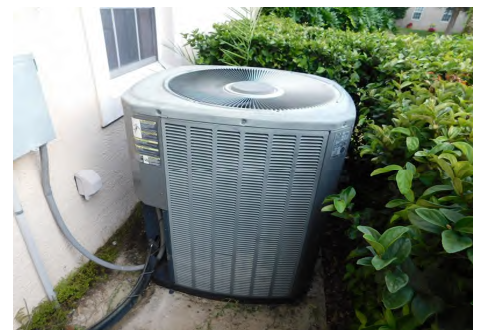
Condenser lines need new insulation. Both units need to be serviced. Upstairs unit needs repairing - Inspector got the unit to turn on briefly- drain sensor was turning the unit off. Drains need to be cleaned.

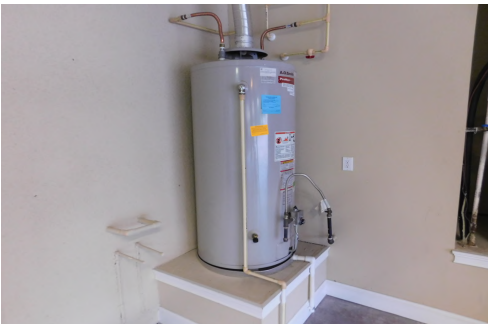
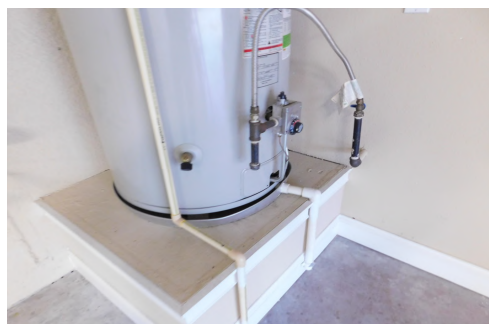
Gas was not on at the time of the inspection - Further inspection is needed.

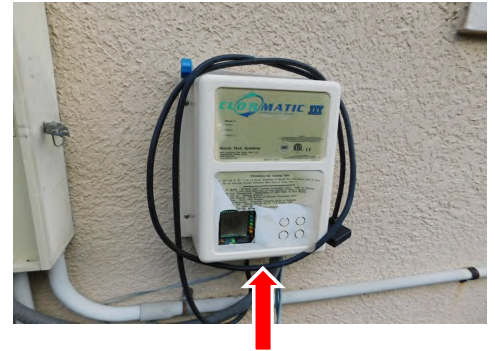
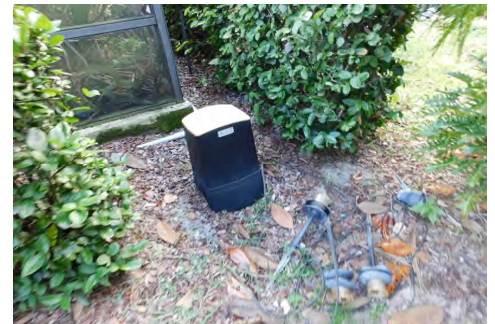
Further Comments: Pool lights are not functional. Lights need to be on a GFCI. Exposed wiring in the pool area - repair. Automatic Chlorinator needs replacing.

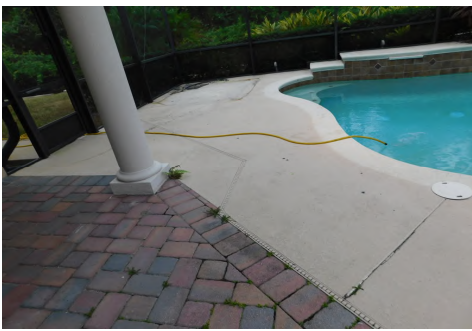
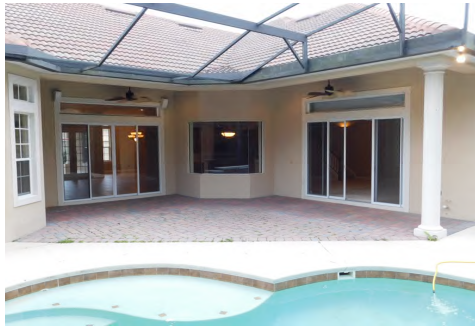
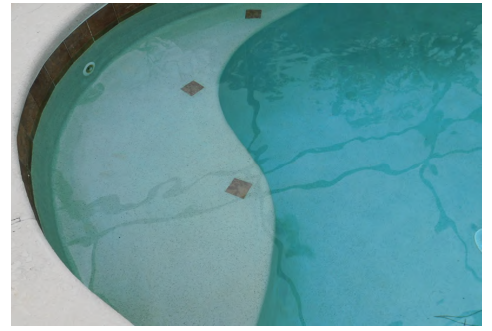
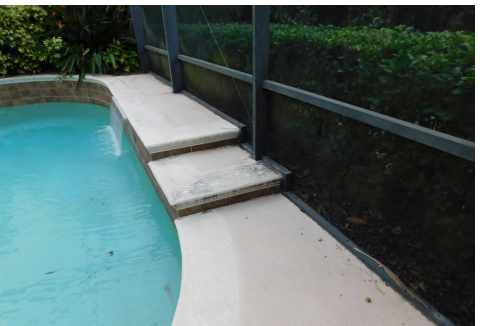
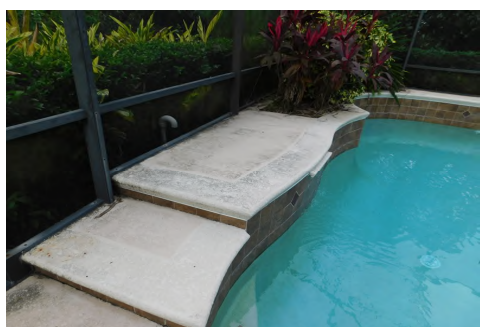
Further Comments: Exterior concrete decking settling cracks noted . Interior pool stains noted. Paver maintenance is needed.

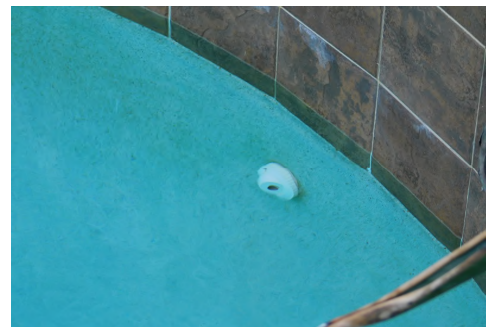
Further Comments: 1- Rain jet needs repairing.
