ALL IN ONE INSPECTIONS

*** Residential Inspection Report ***

123 Main Street
Orlando , FL 32222

Date Of Inspection: March 26, 2014

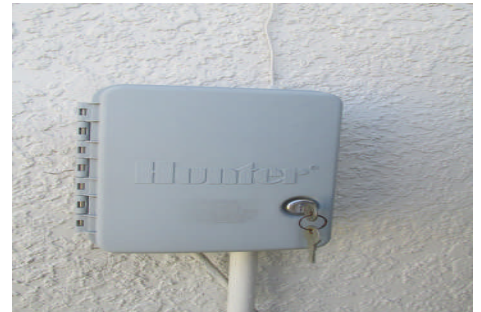
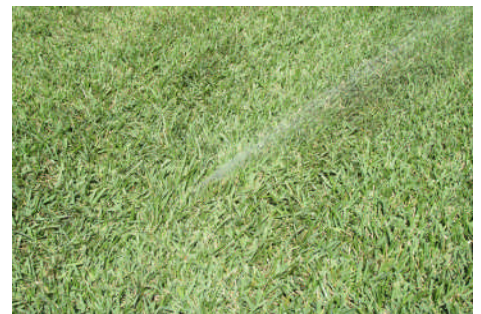
Further Comments: Maintenance needed on all heads.

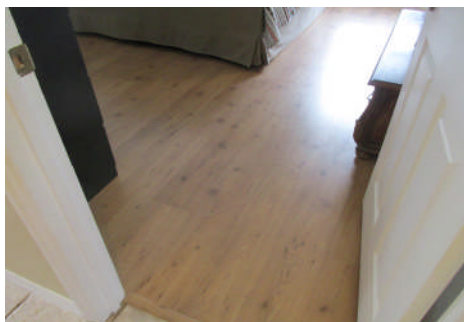
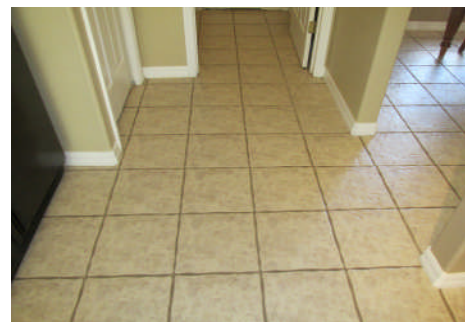
Further Comments: Stress cracks noted by kitchen.

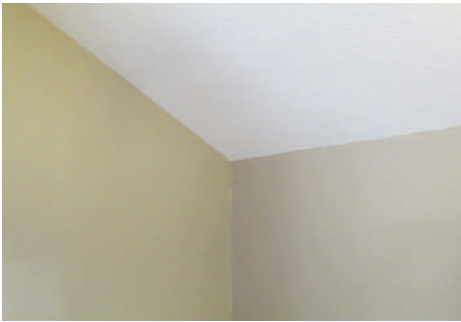
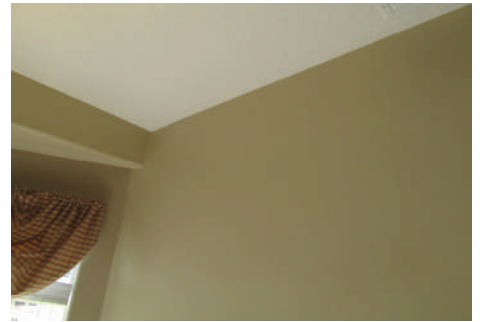
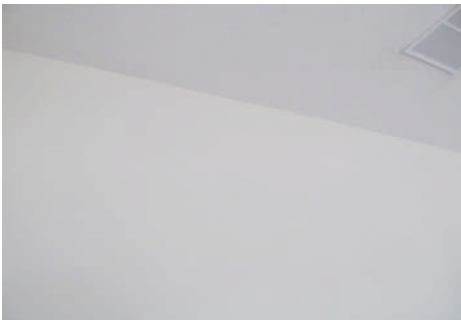
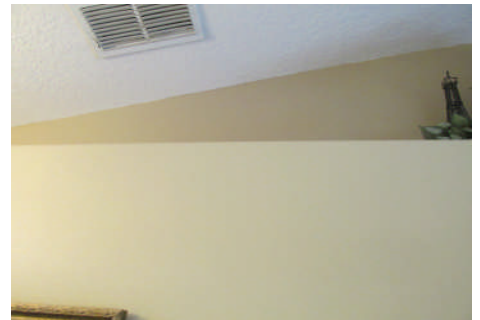
Further Comments: Seam on ceiling in family room was repaired. Need minor sealing.

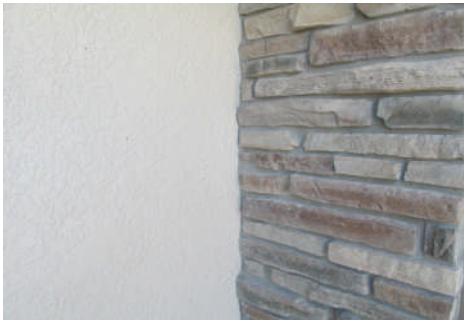
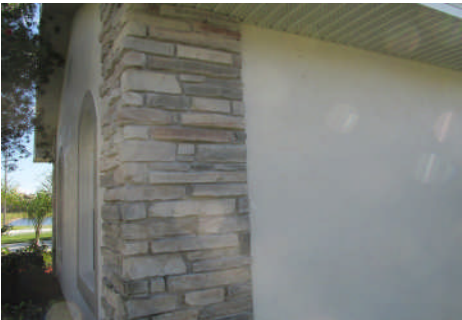
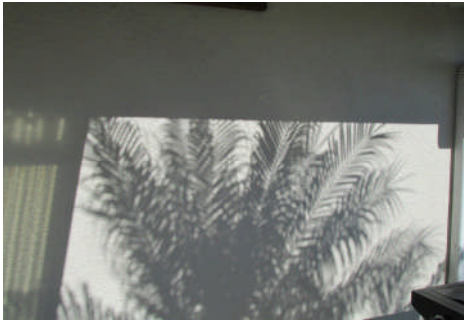
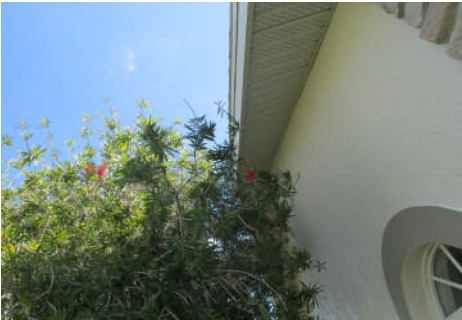
Material: Stucco and stone
Further Comments: Reseal stucco cracks

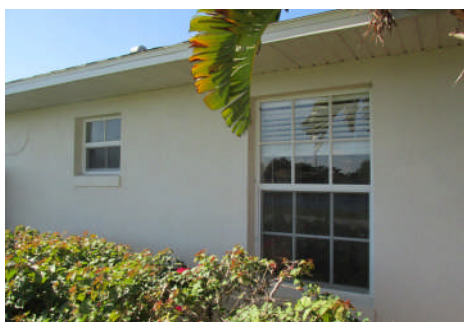
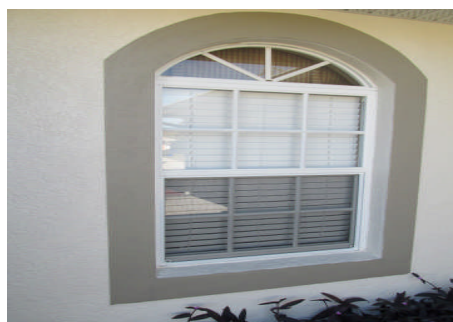
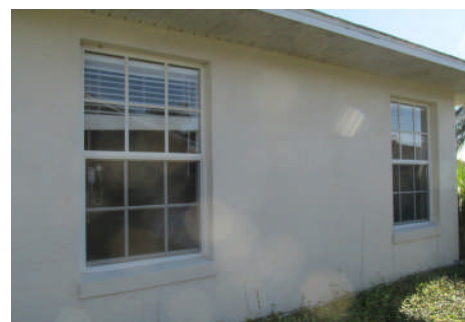
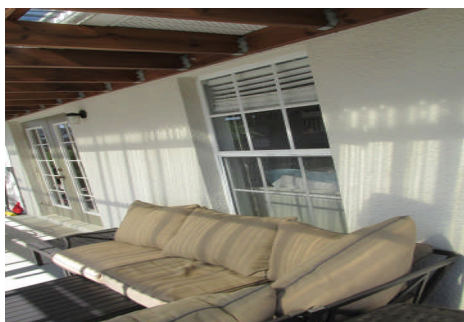
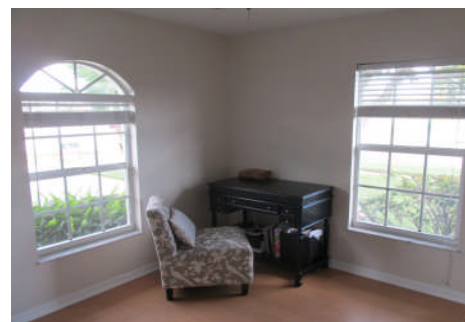
Further Comments: Windows on the interior and exterior need resealing. One marble sill is damaged.

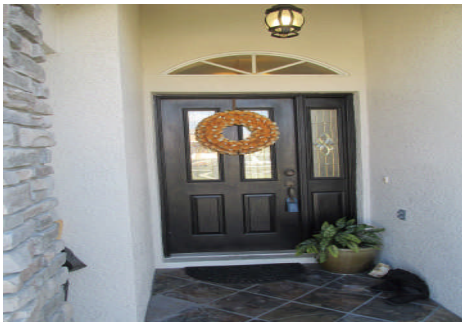
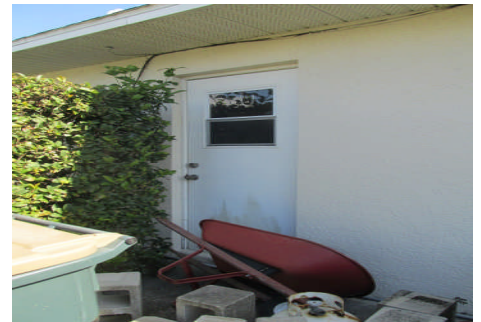
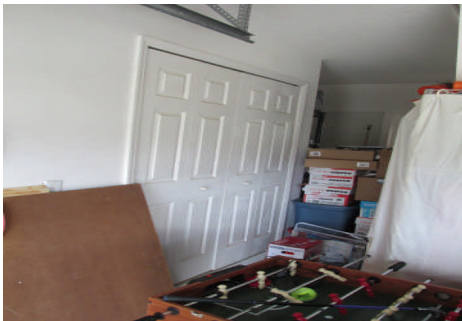
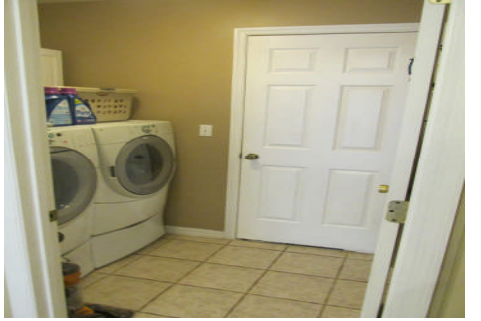
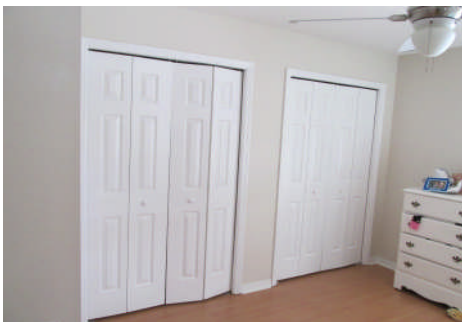
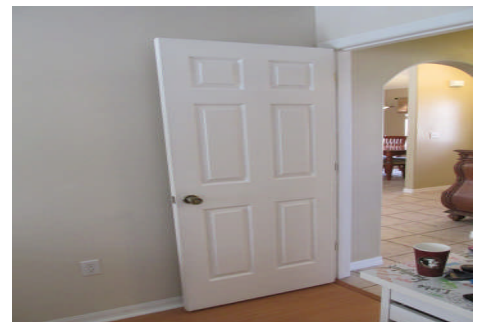
Further Comments: French doors hinges need to be secured. Side pedestrian door has rot on bottom of door and frame.

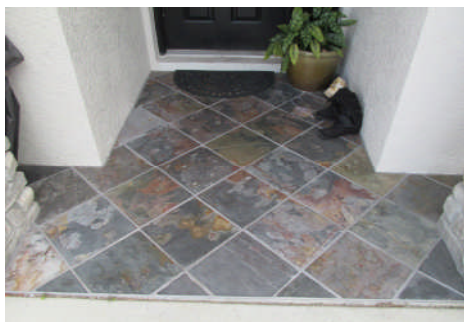
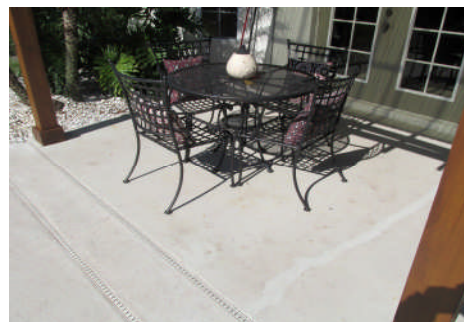
Further Comments: Stress crack noted.

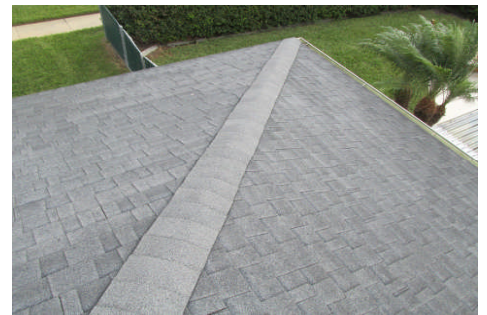
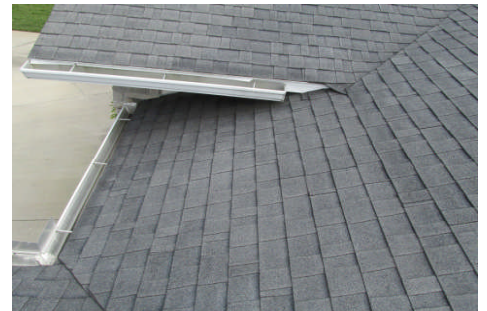
Further Comments: Patched area noted on ridge caps.

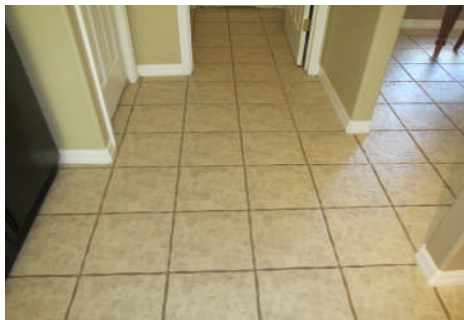
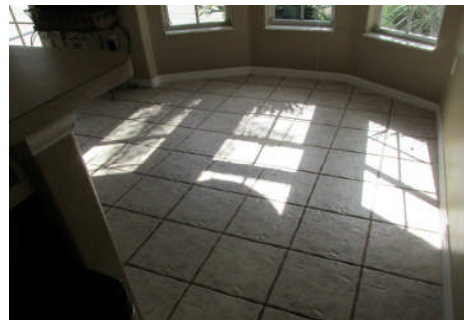
Further Comments: Stress crack noted.

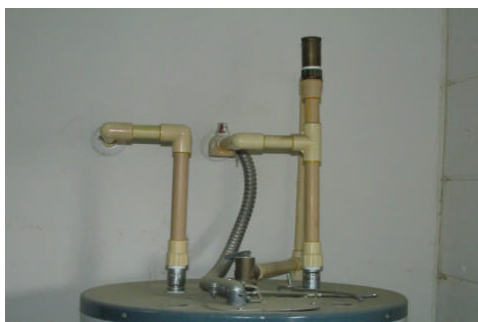
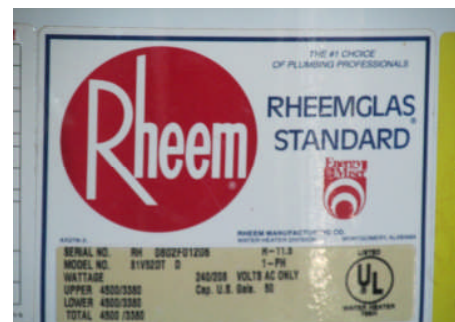
Noted: clean stuff away from unit.

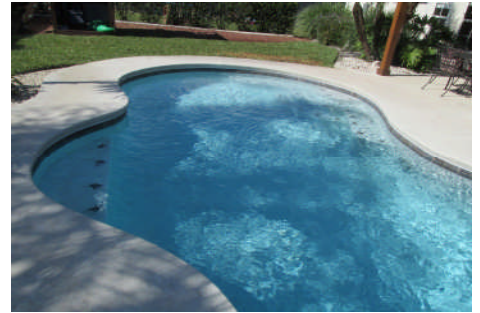
Further Comments: Stains on interior of walls and floor of the pool.

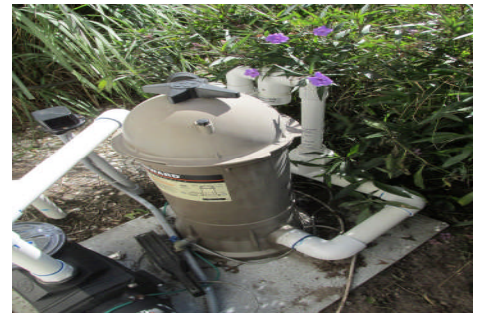
Further Comments: Leak in PVC piping next to pump.
