All In One Inspections

*** Residential Inspection Report ***

July 3, 2017

123 Main Street
Windermere, FL 34786

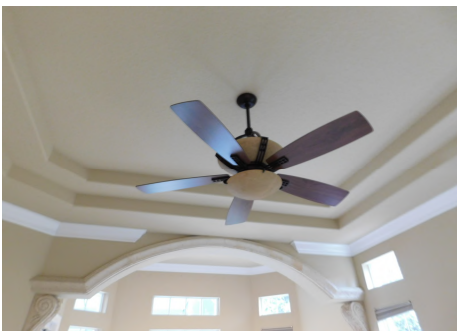
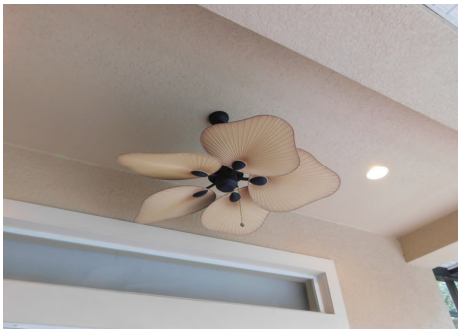
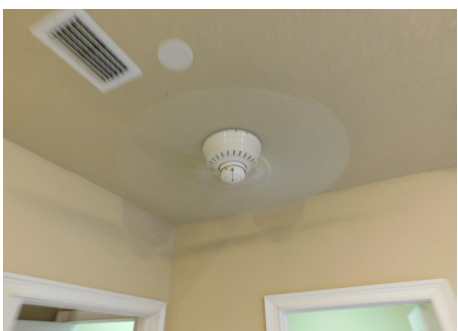
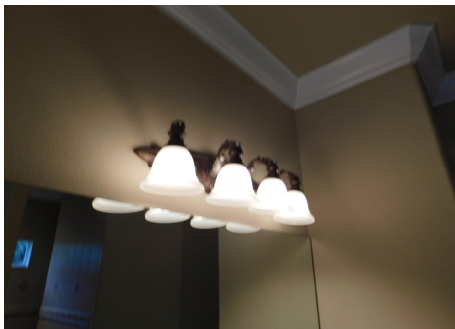
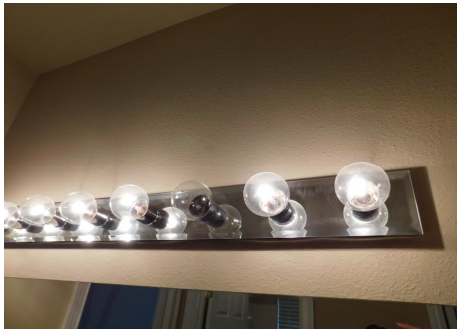
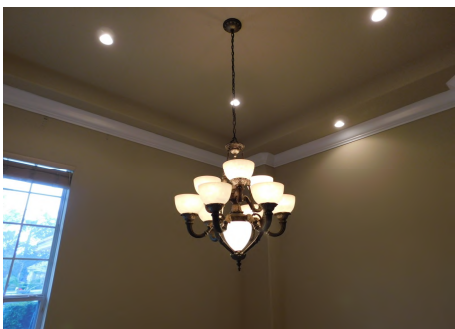
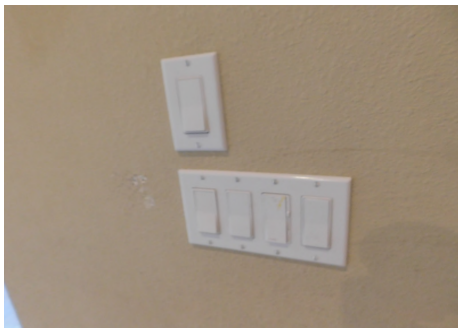
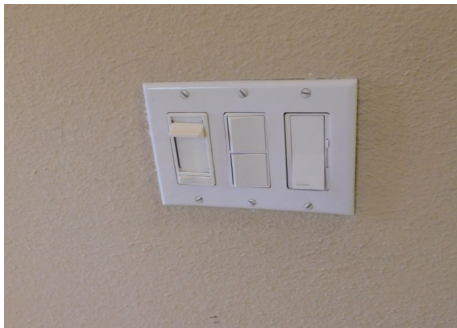
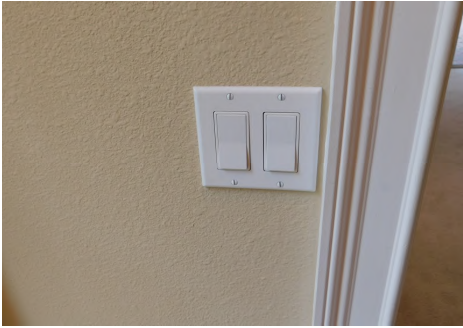
Observation: Various light bulbs are burned out. 1 fan needs a remote.

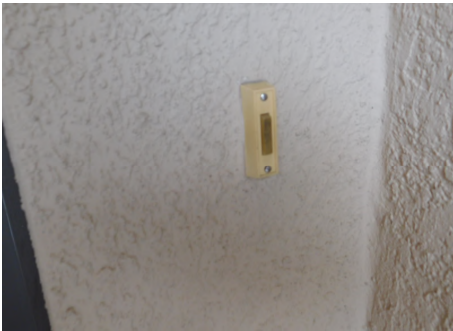
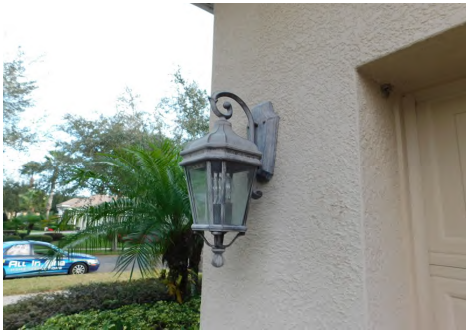
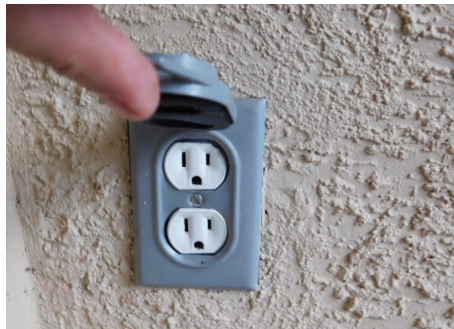
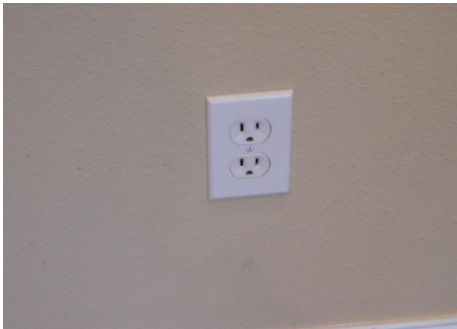
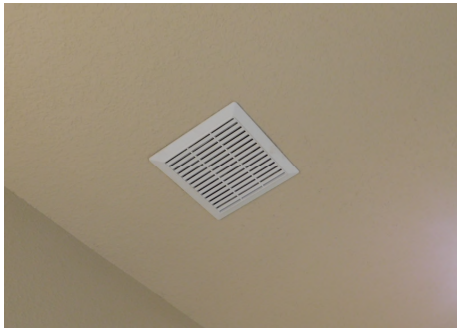
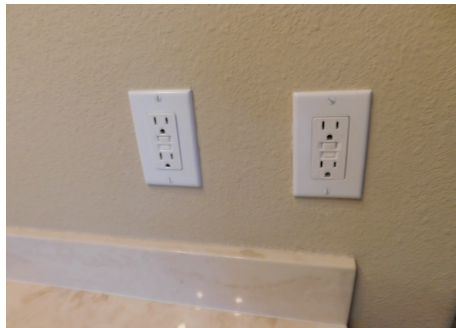
Observation: Exterior fixtures need to be sealed. 2+ Outlets are insecure. Exterior spotlights need minor repairing. Moted: Bathroom exhaust fans are functional.

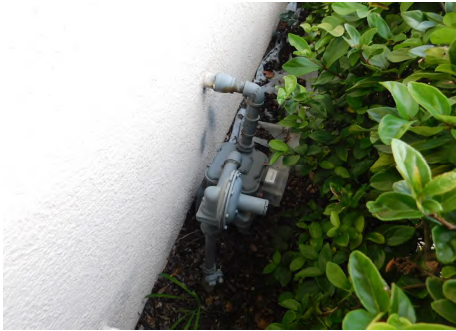
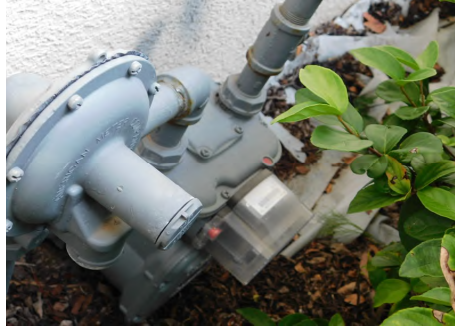
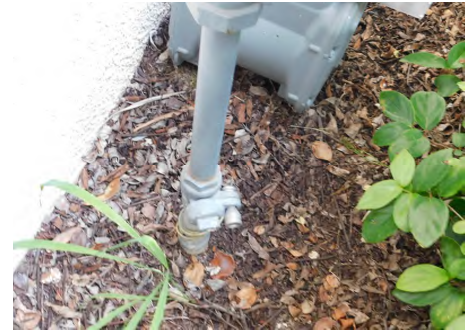
Gas was not at the time of inspection.

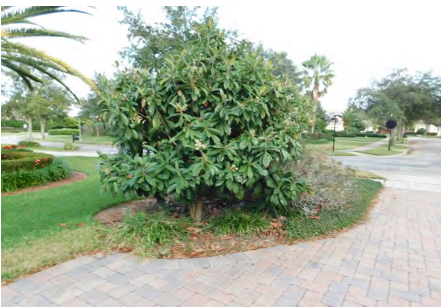
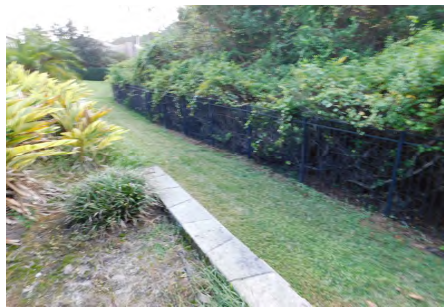
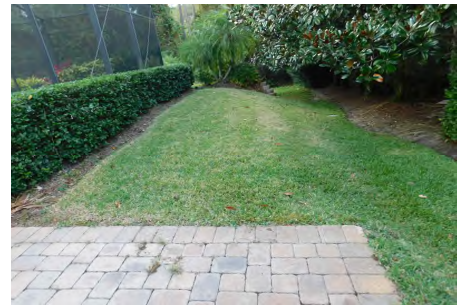
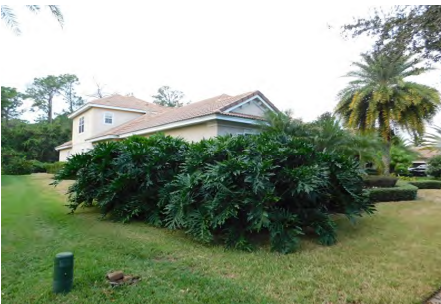
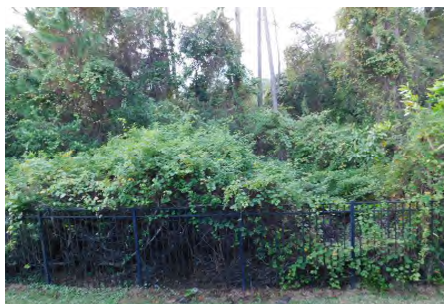
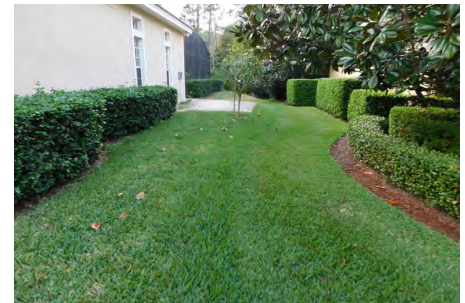
Further Comments: Trees/shrubs are too close to foundation. Maintenance is needed.

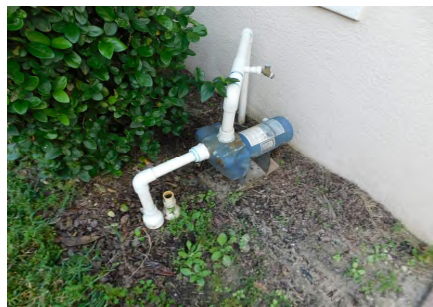
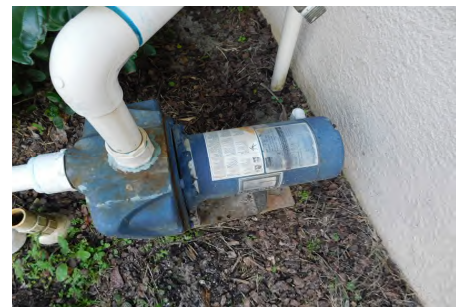
Further Comments: The well needs to be primed.

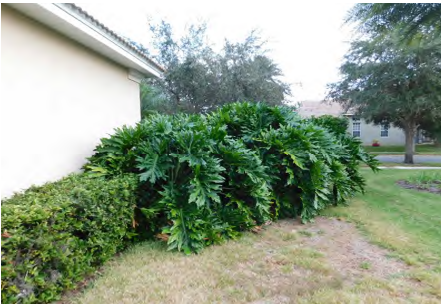
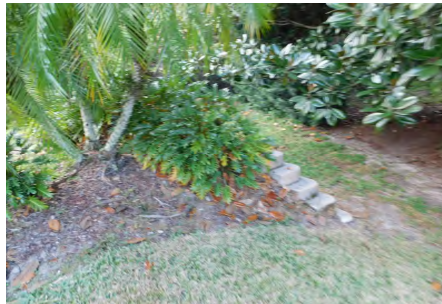
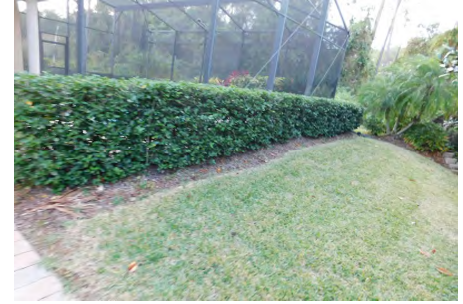
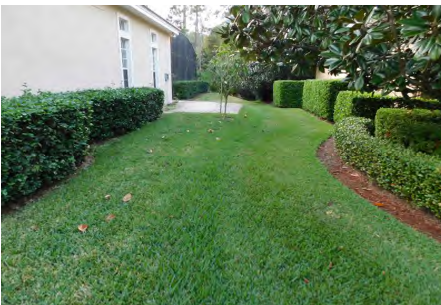
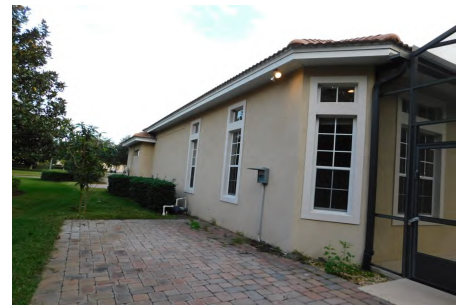
Further Comments: Addition gutters recommended. Maintenance is needed.

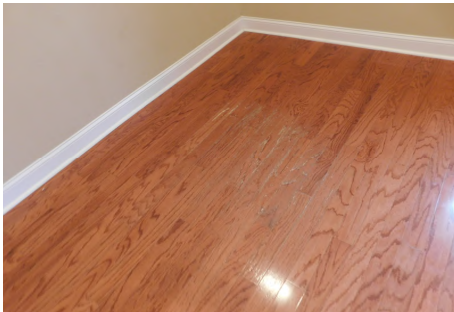
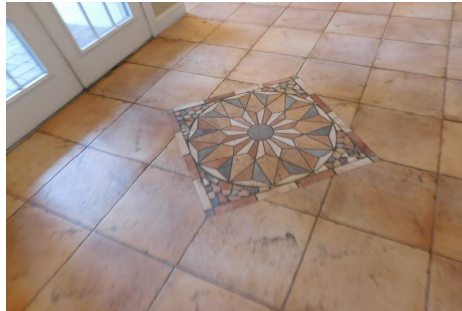
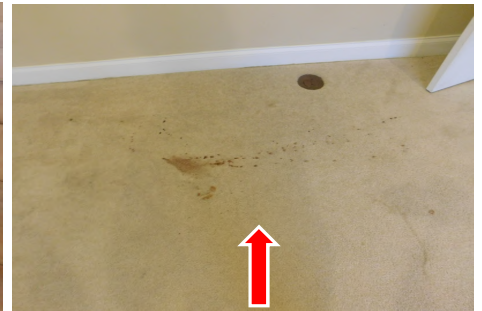
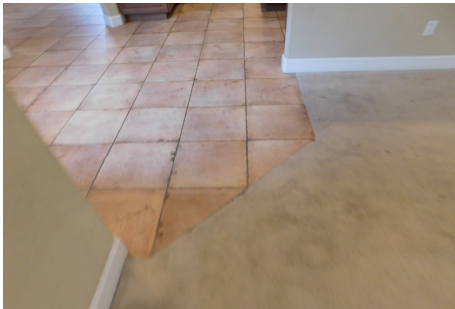
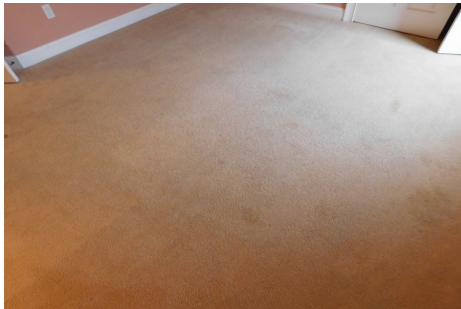
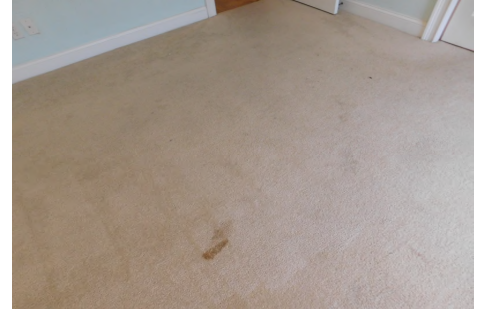
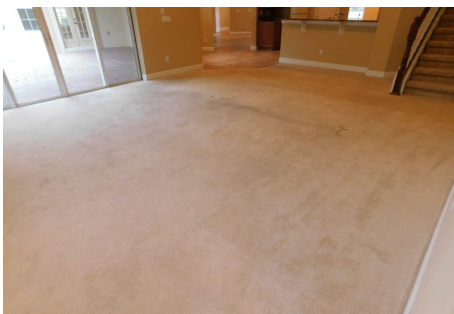
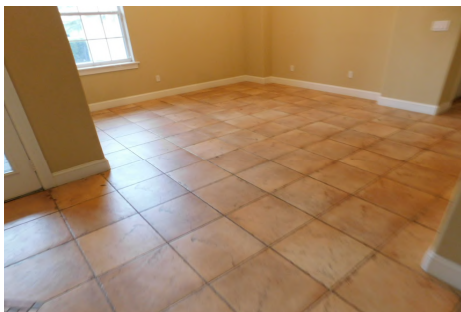
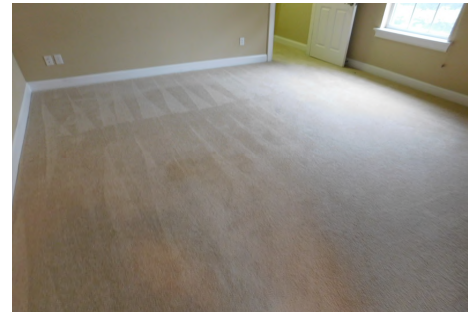
Further Comments: Carpet stains noted. Wood shows wear in the office area..

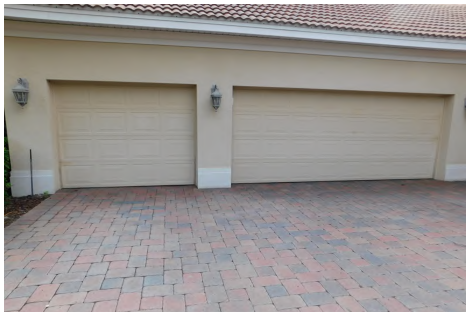
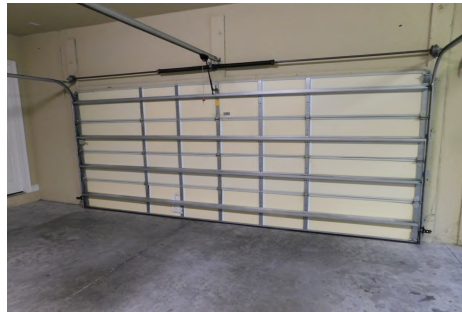
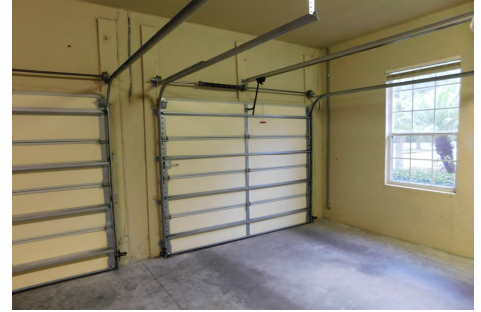
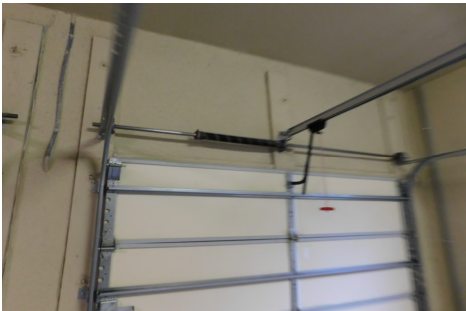
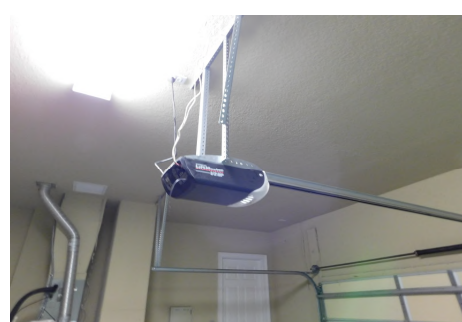
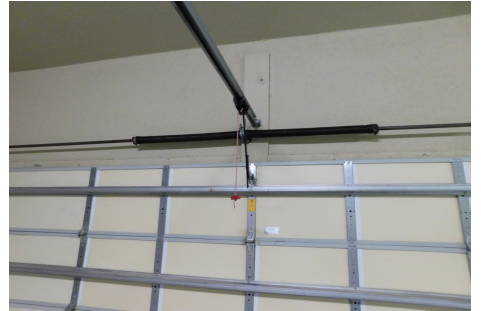
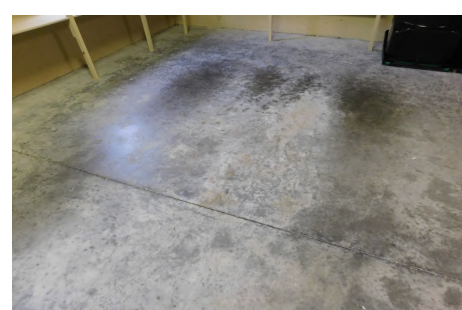
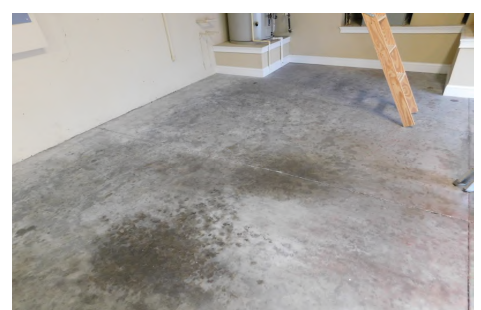
Further Comments: 1 Car Garage door opener is nonfunctional. Auto reverse functionality in the 1 car garage is unknown. Concrete settling cracks noted. Lube rollers and rail.

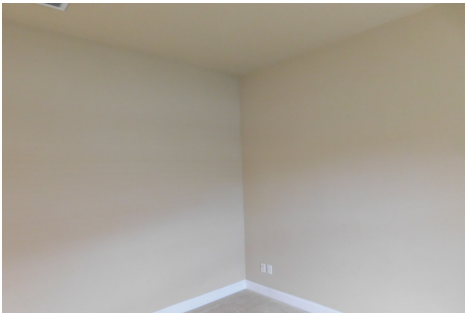
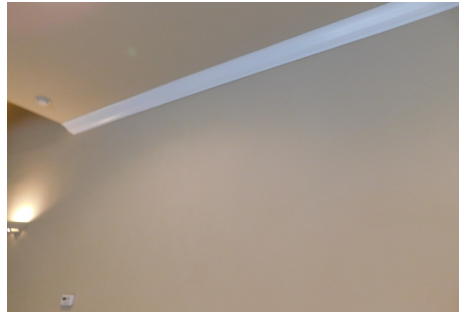
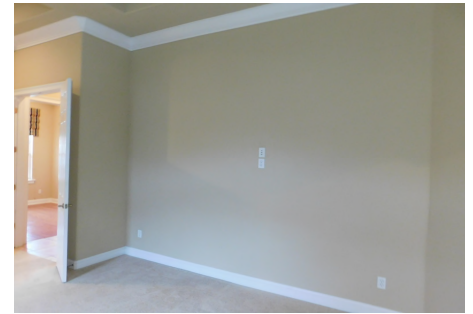
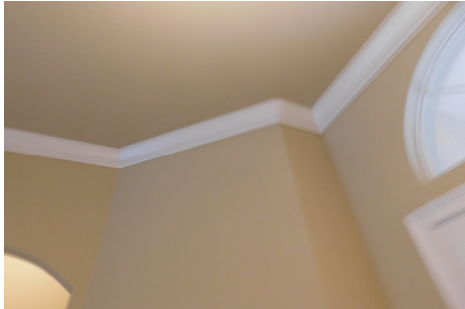
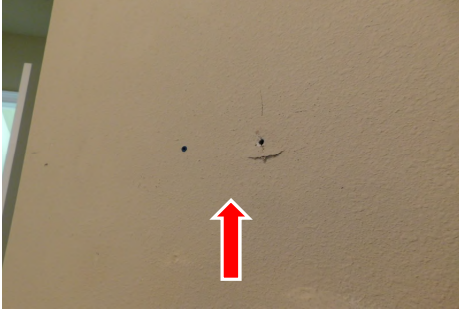
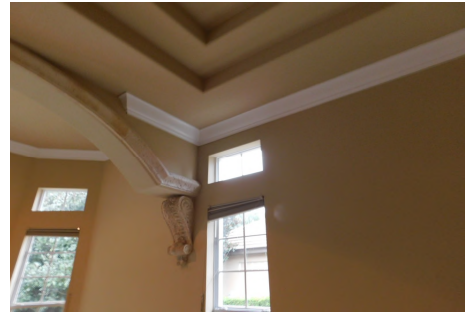
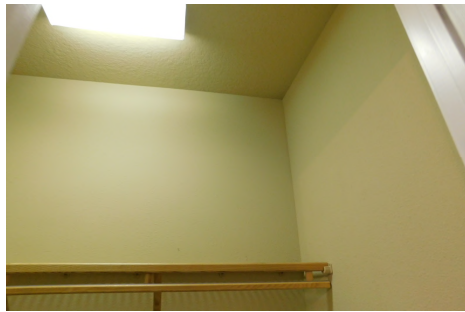
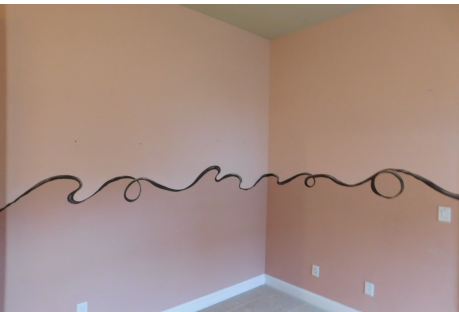
Further Comments: Stains and dirt noted on ceilings and walls. Minor wall holes noted throughout home.

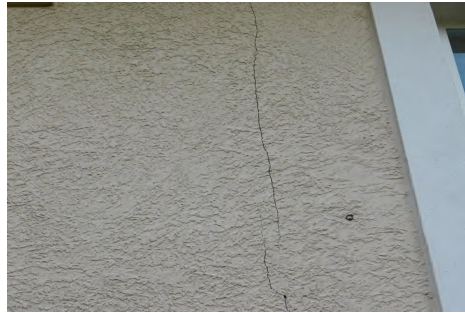
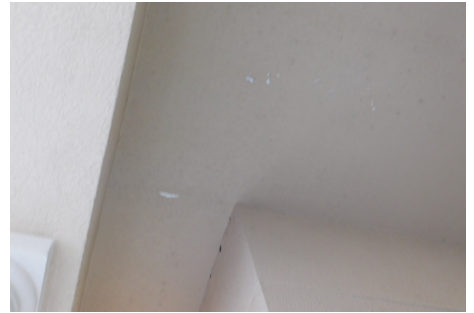
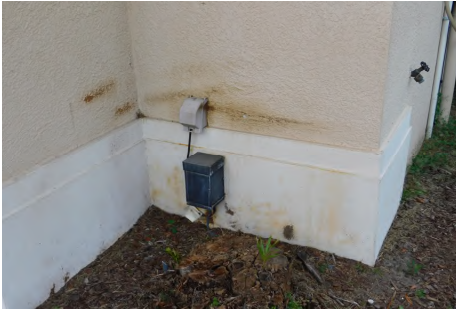
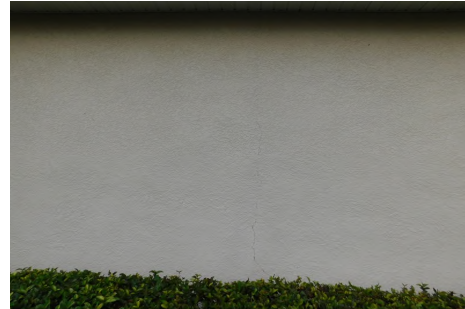
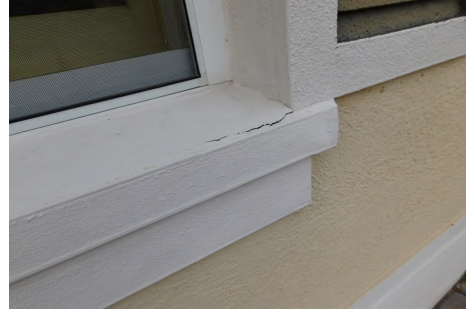
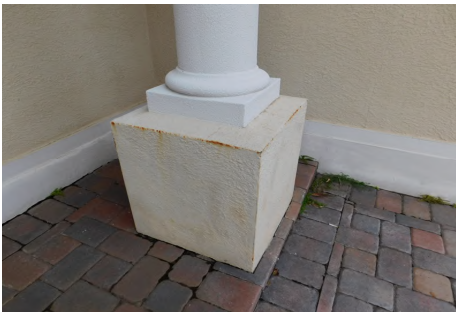
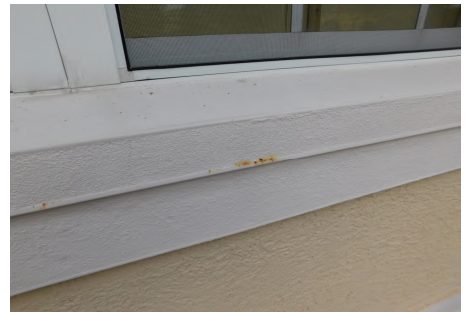
Further Comments: Reseal stucco cracks on all walls. Rust noted on front exterior wall edges. Clean, Seal and Paint.

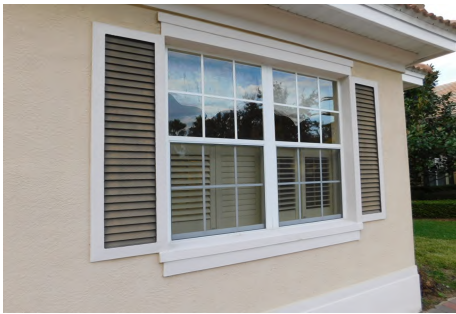
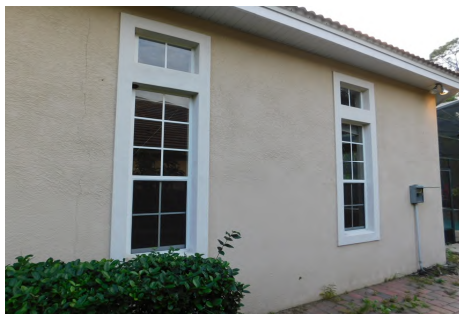
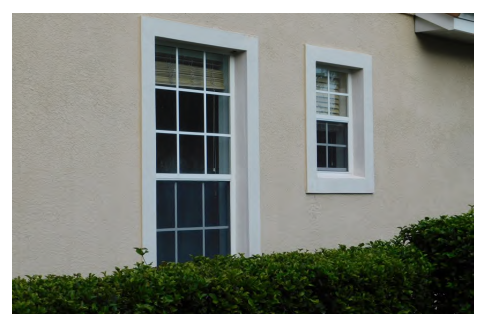
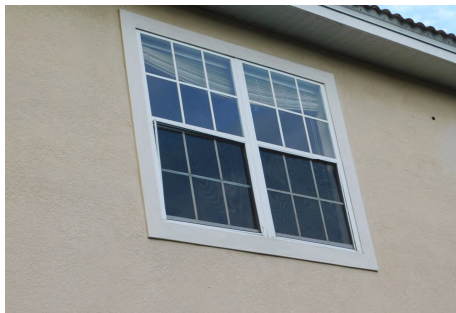
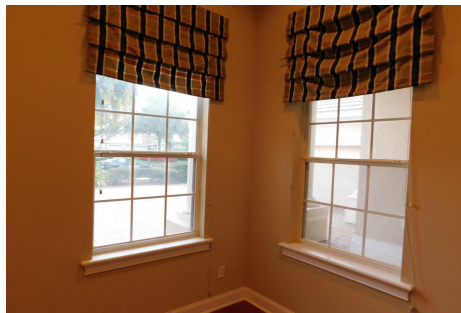
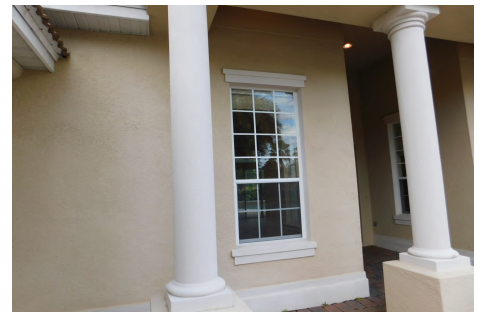
Further Comments: 2 Windows and 2 Screens are damaged and need repairing - 1- Upstairs and 1- bedroom rear downstairs. 1 Window lock is not functional. Seal the interior and the exterior of the windows. Windows need maintenance and oiling.

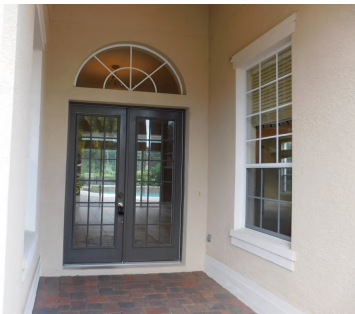
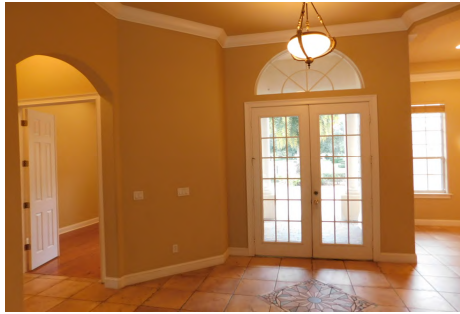
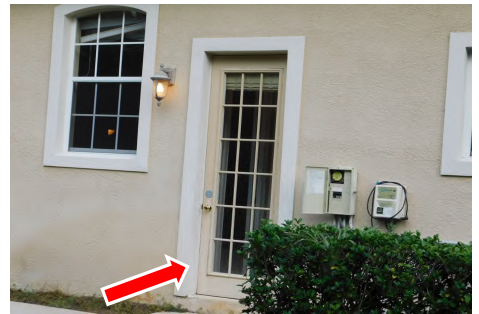
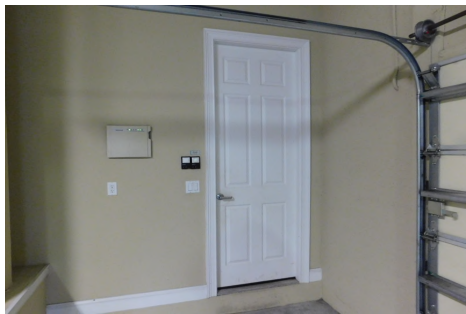
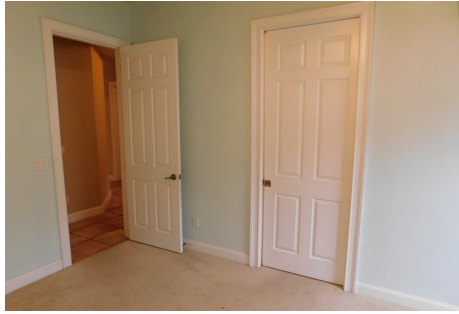
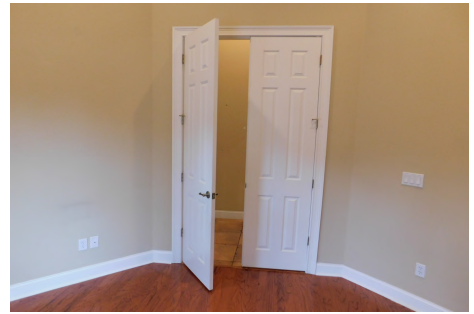
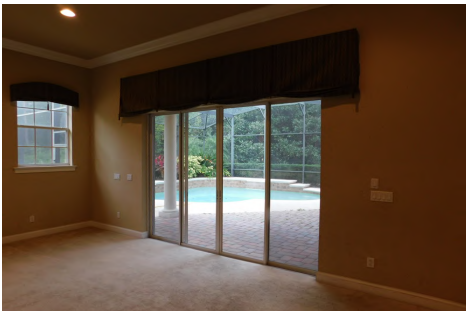
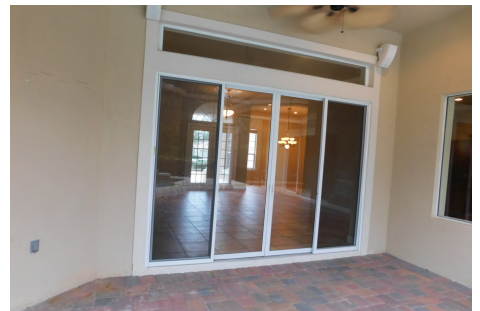
Further Comments: Exterior sliding door needs sealing and maintenance. Rear pedestrian door/frame is damaged and needs to be replaced. Front door - bottom bolt - needs minor repairing.

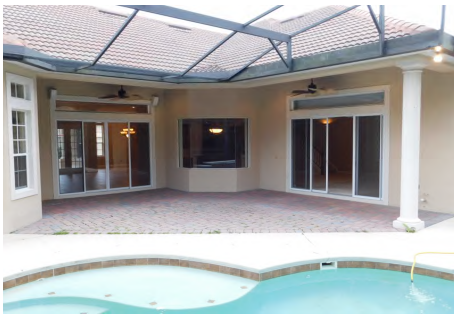
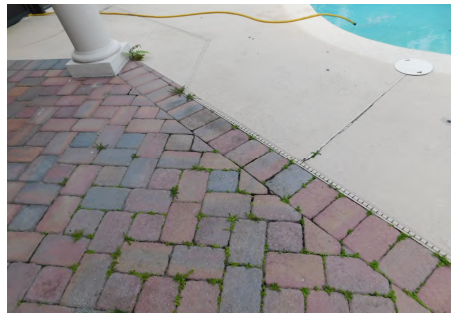
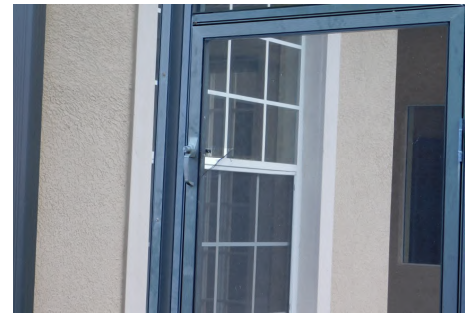
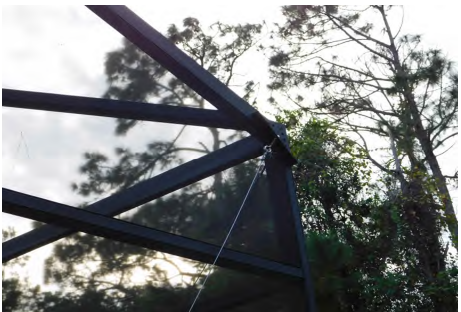
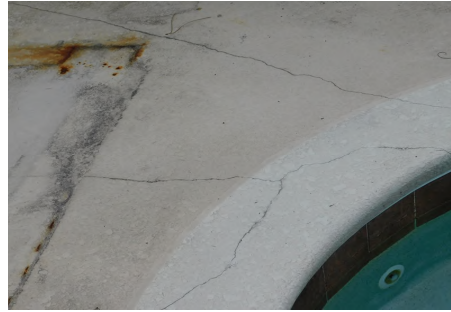
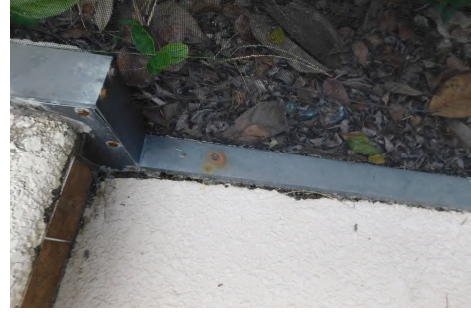
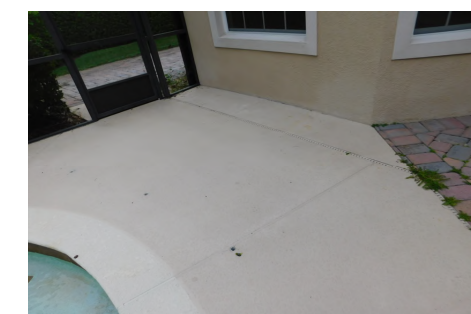
Further Comments: Concrete settling cracks. Sill plates need securing - Bolts are rusted or missing. . 4+ Screens are missing/damaged. All tie downs need adjusting/repairing. Weep holes recommended. Clean channel drains and gutters. Maintenance is needed.

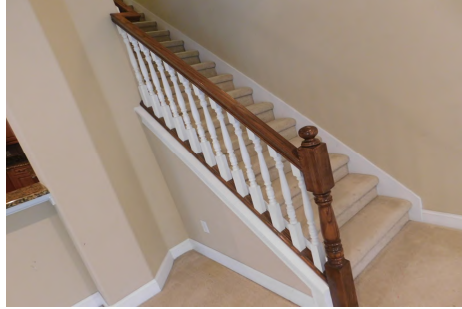
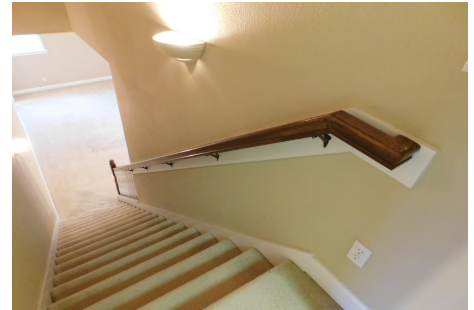
Further Comments: No major concerns observed.

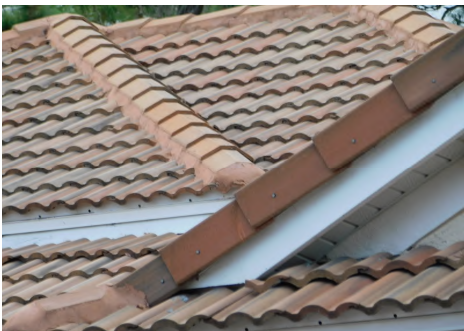
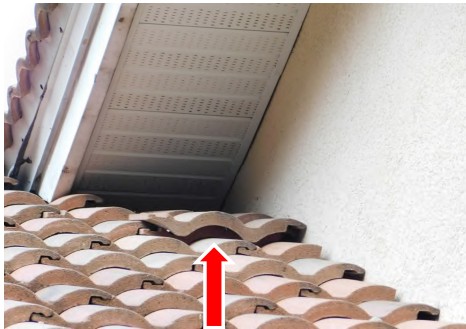
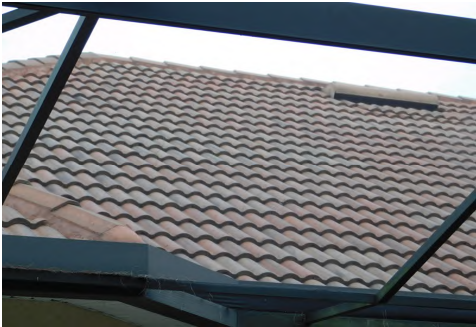
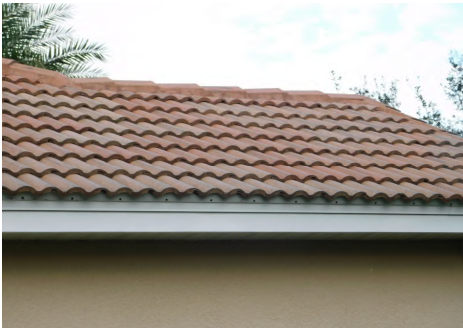
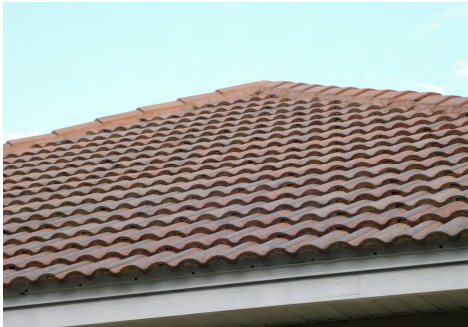
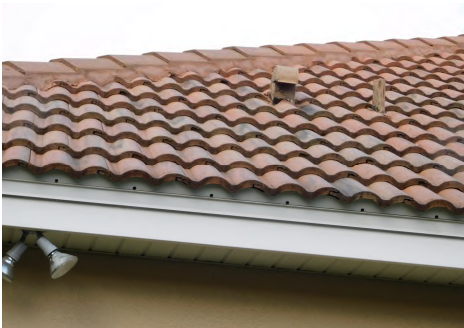
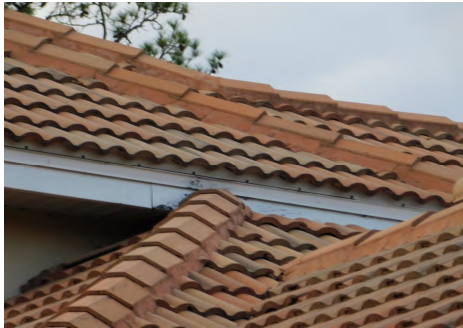
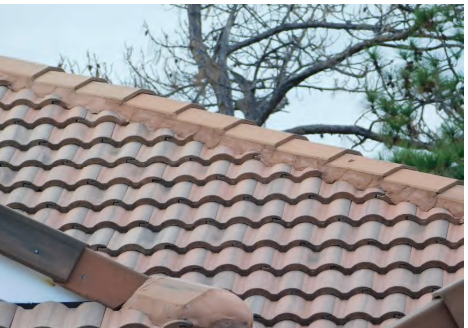
Material: Tile
Viewed from: From the ground
Further Comments: 2+ tiles need repair.

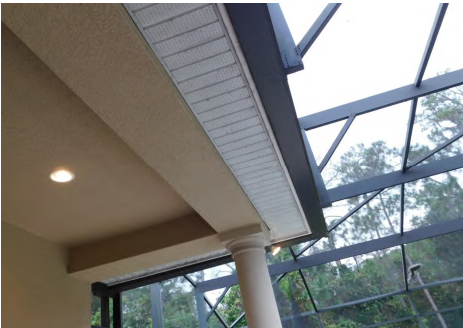
Further Comments: Recommend getting additional gutters. Gutters are in the rear only. Maintenance and resealing are needed.

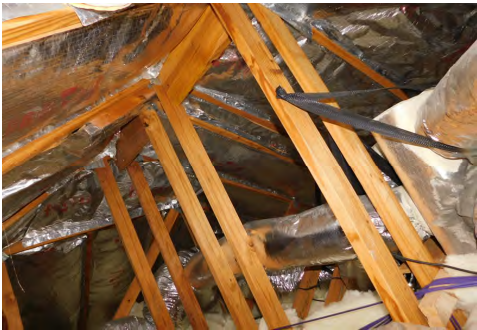
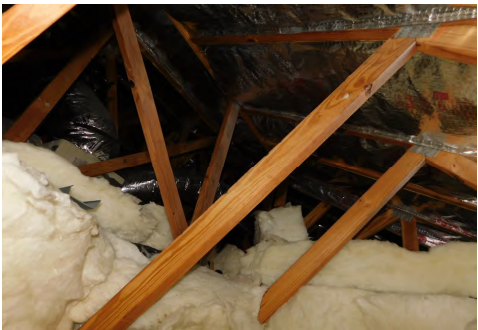
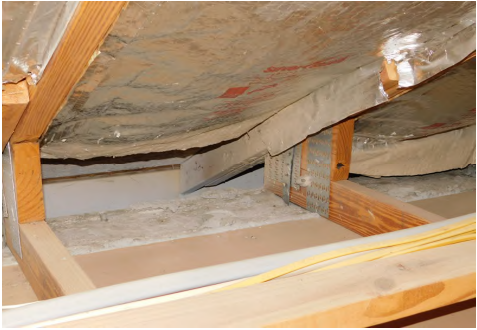
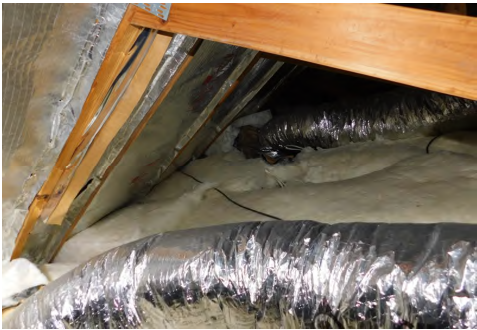
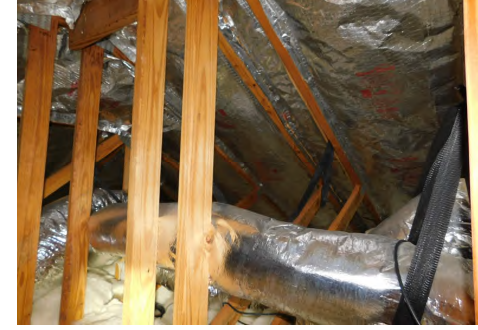
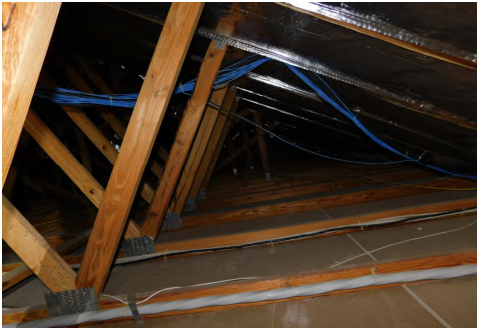
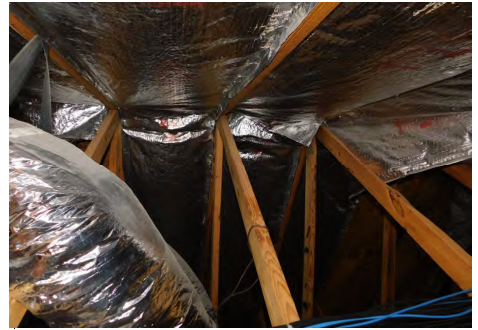
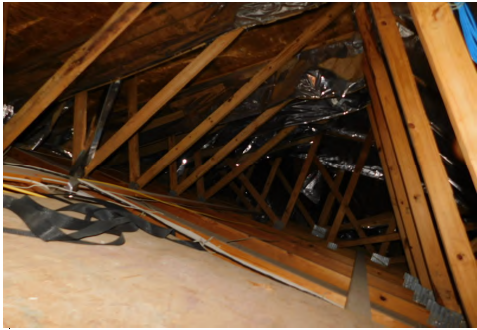
Viewed From: By entering crawl space and ladder Access: Hatch and pull down
Vent Screens Adequate % of Attic Inspected: 30
Further Comments: Limited access due to vents and trusses.

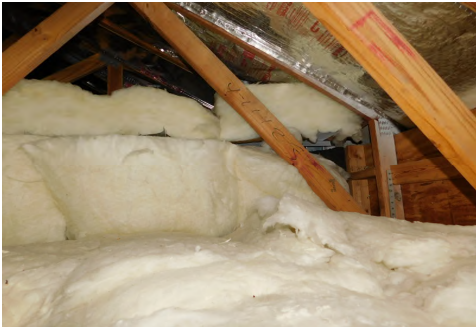
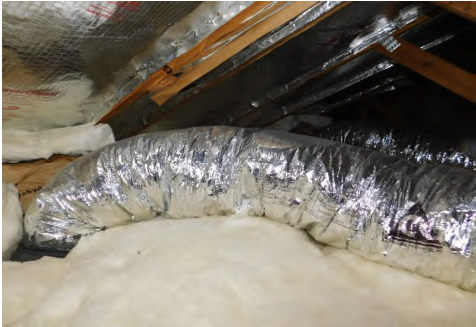
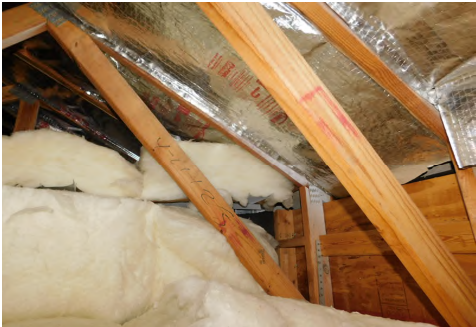
Materials: Fiberglass batt Thickness: 8-9 inches
Further Comments: No concerns observed.

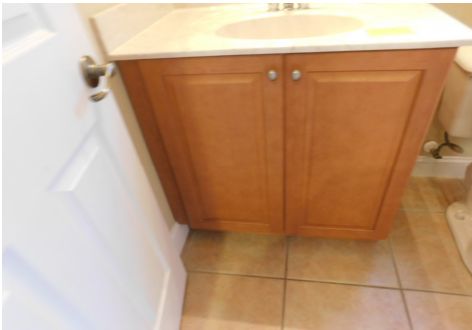
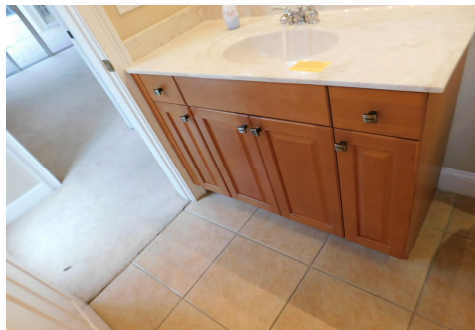
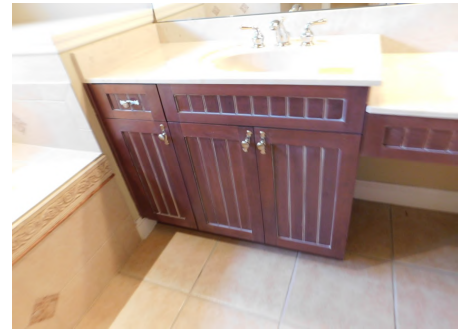
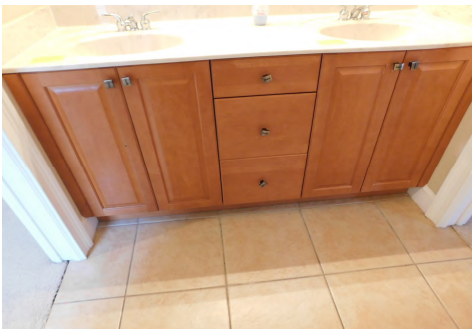
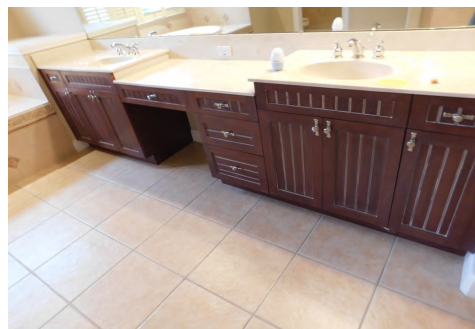
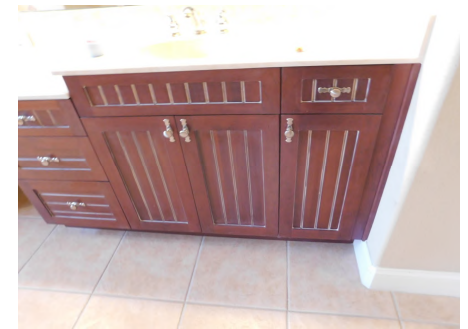
Further Comments: No concerns observed.

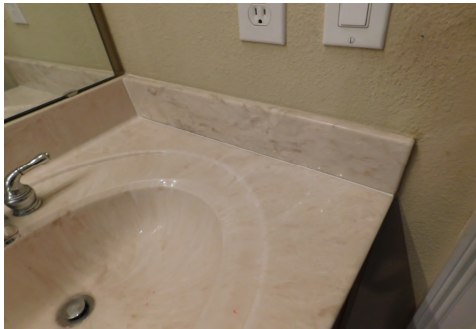
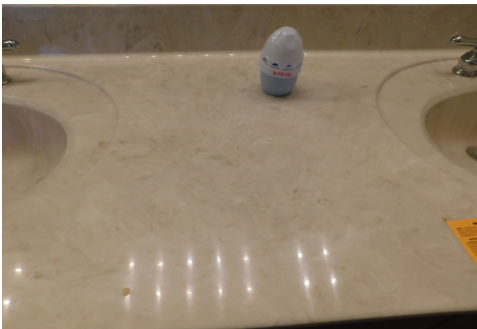
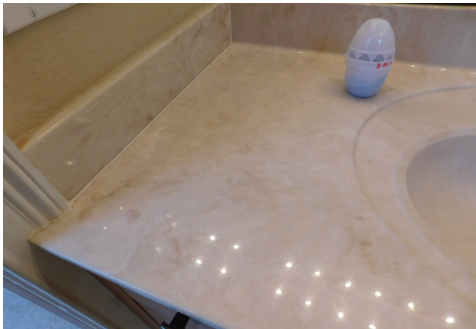
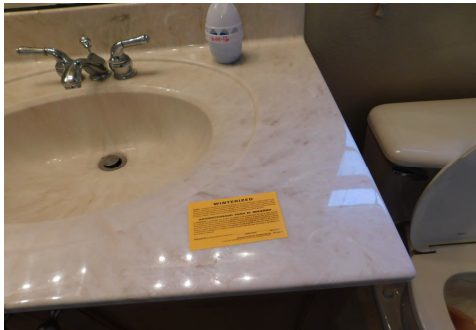
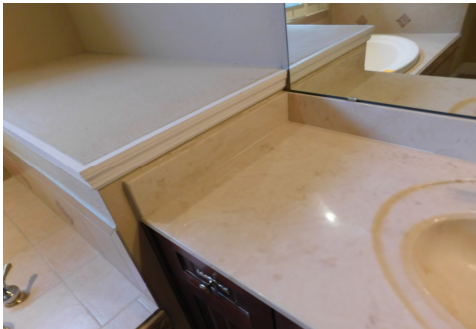
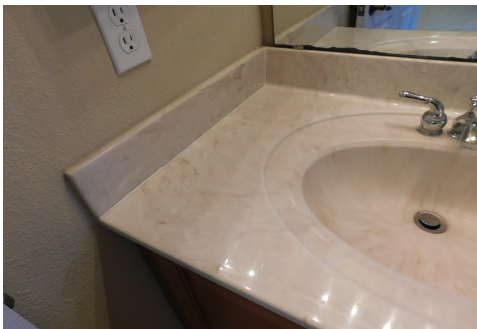
Material: Faux marble
Further Comments: No concerns observed.

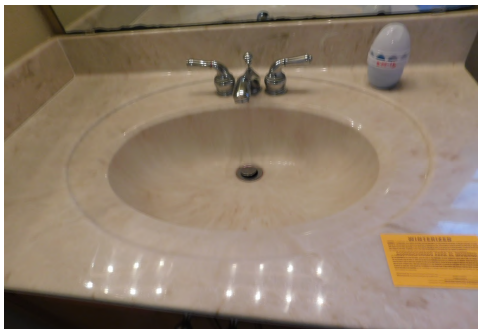
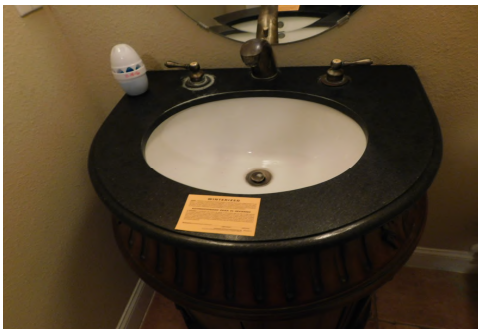
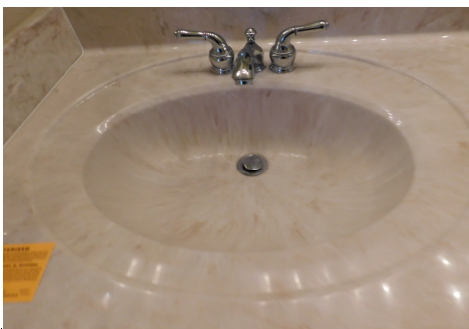
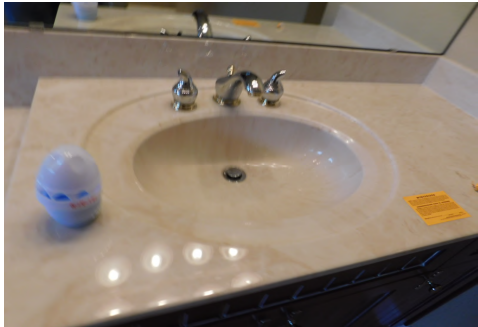
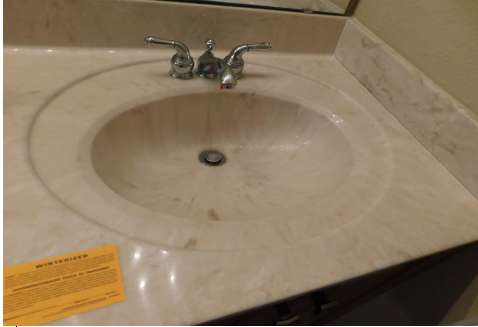
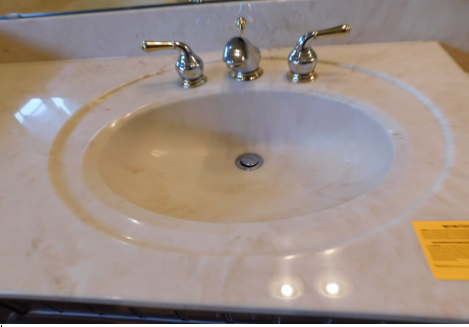
Further Comments: No concerns observed.

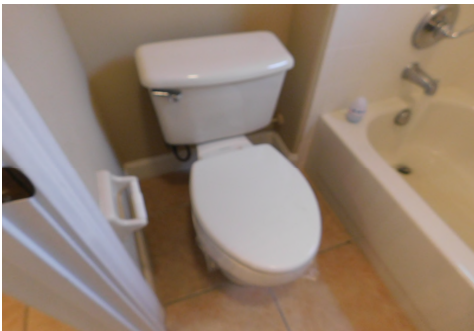
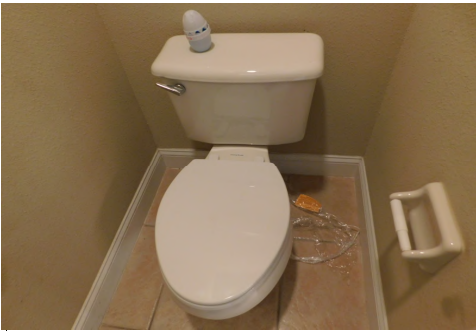
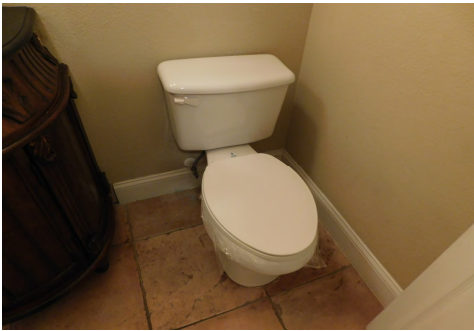
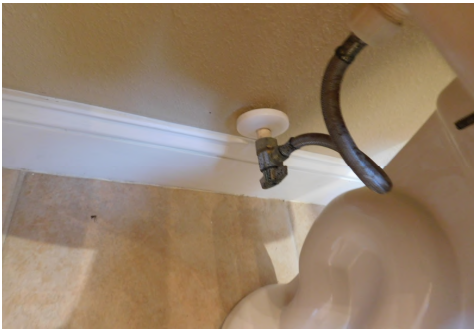
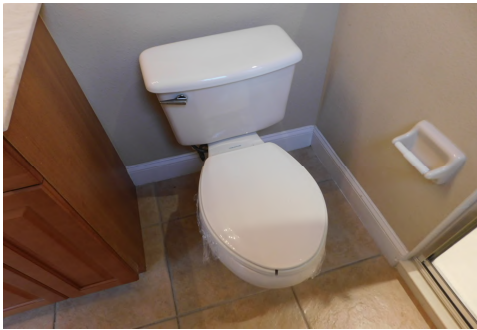
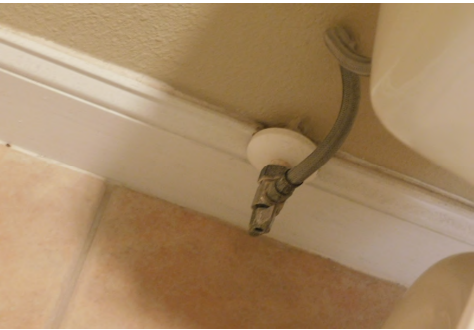
Type: Porcelain
Toilet Secure: Yes
Further Comments: No concerns observed.

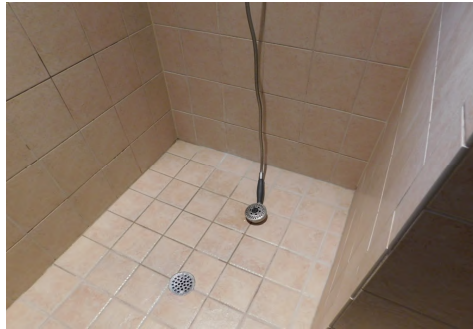
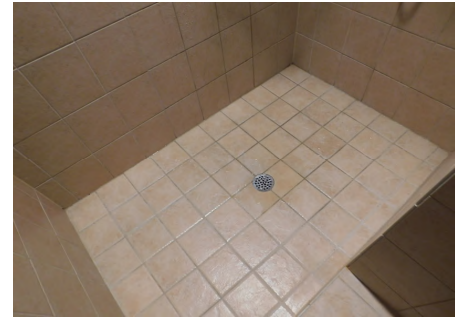
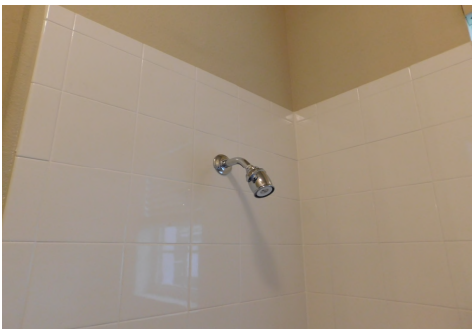
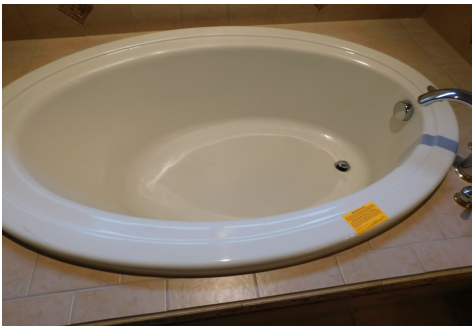
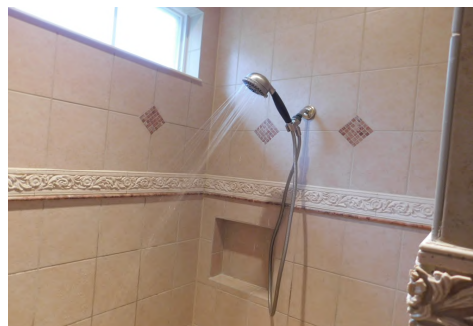
Shower stall needs sealed: Yes **Shower head missing** No

Further Comments: Showers and tub surrounds need to be sealed.

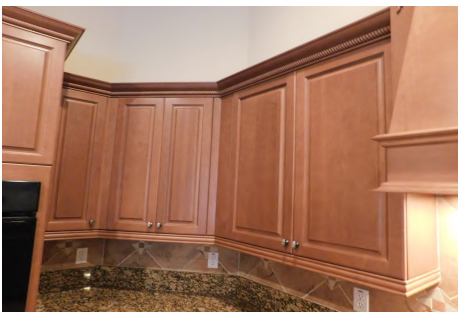
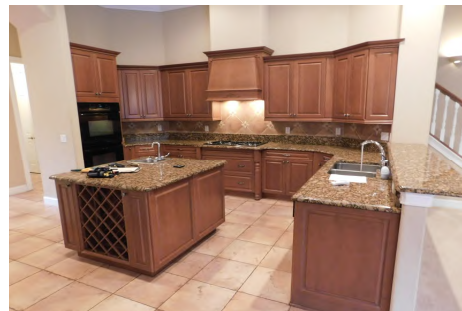
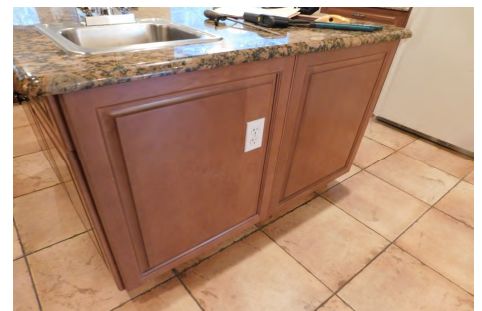
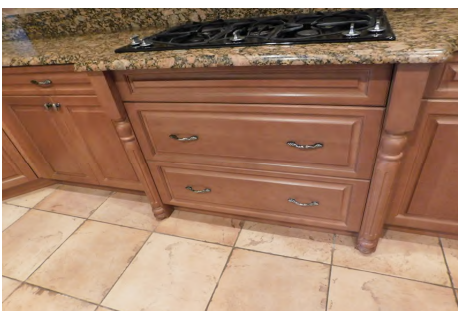
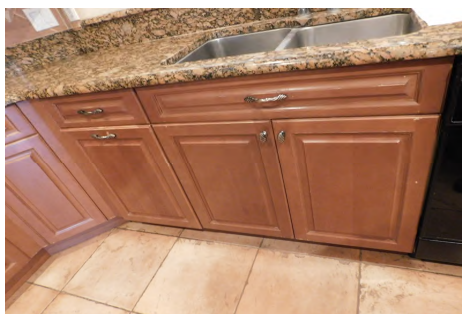
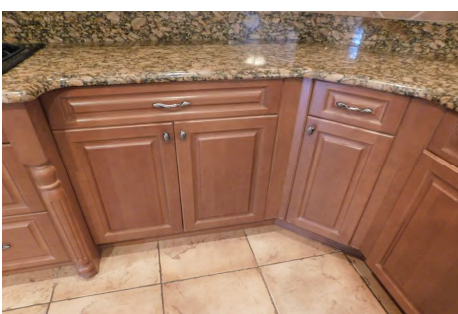
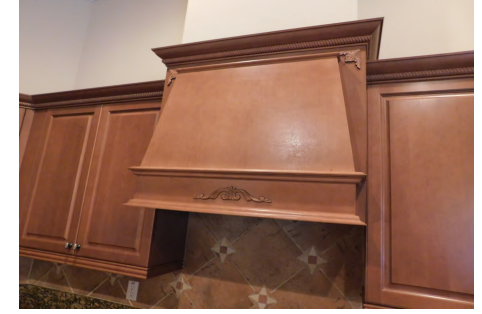
Material: Wood Cabinets

Further Comments: No major concerns observed.

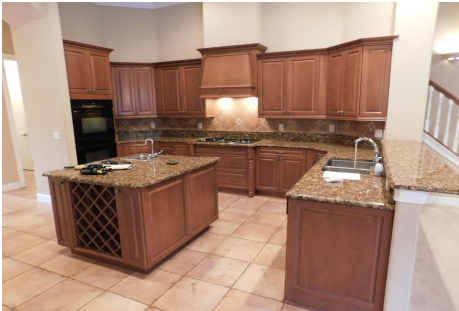
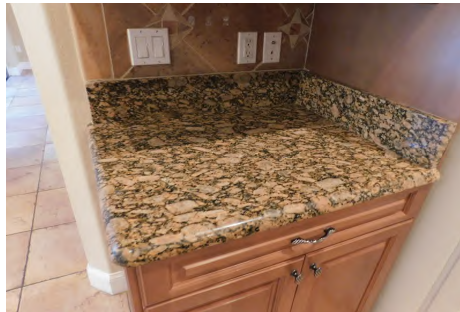
Material: Granite countertops

Further Comments: No concerns observed.

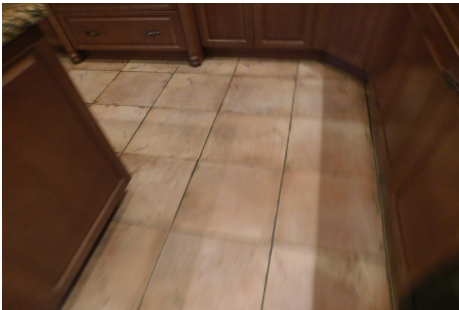
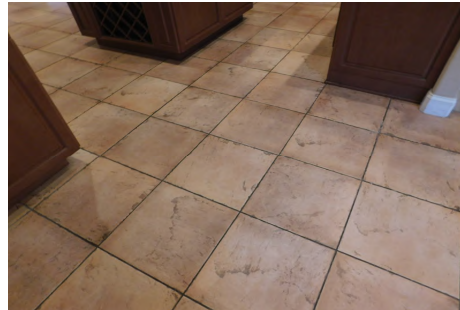
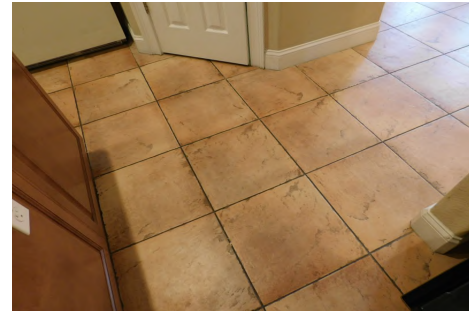
Floor Covering (Kitchen)

Material: Tile

Further Comments: No concerns observed.

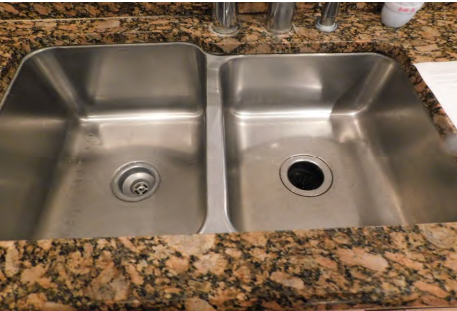
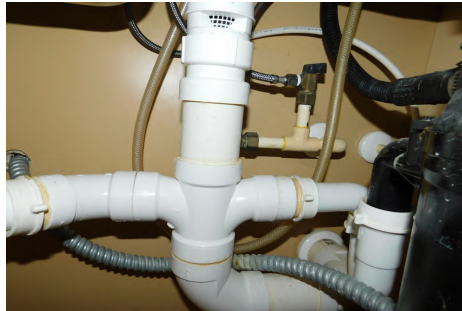
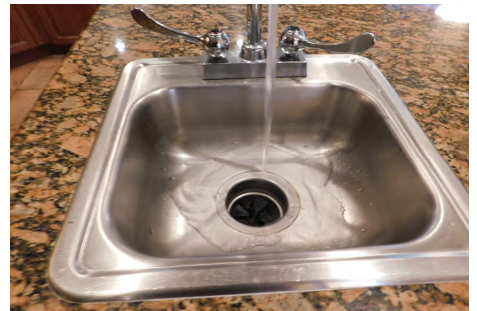
Material: CPVC and PVC

Further Comments: No concerns observed.
