All In One Inspections

*** Residential Inspection Report ***

July 3, 2017

123 Main Street
Windermere, FL 34786

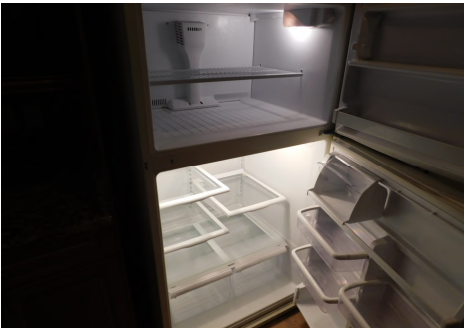
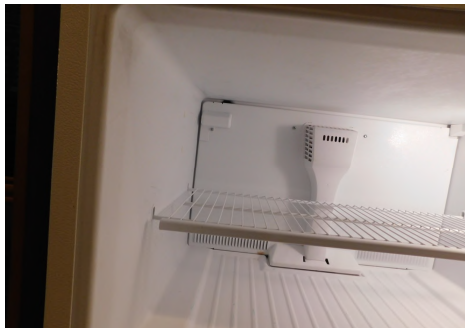
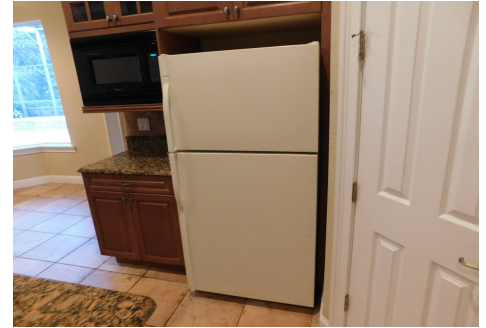
Noted: No ice maker.

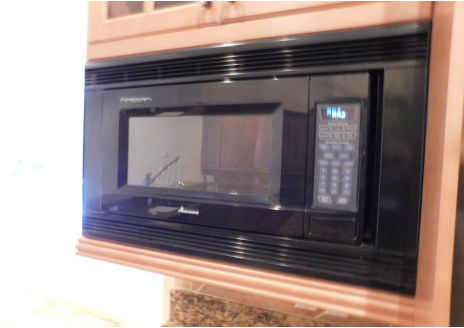
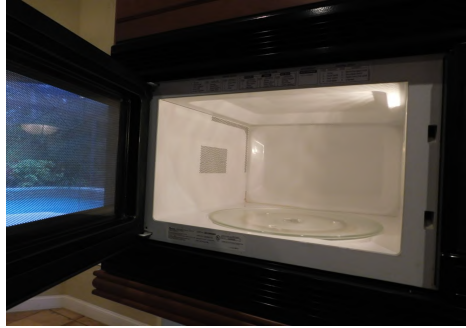
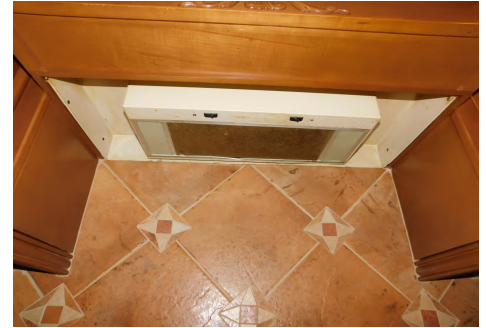
No concerns observed.

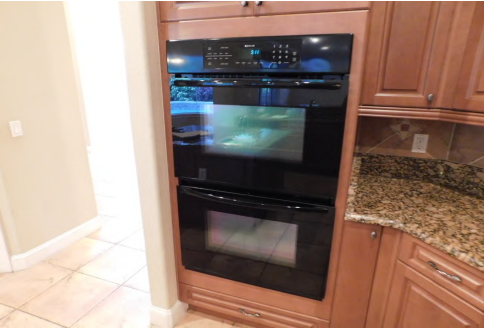
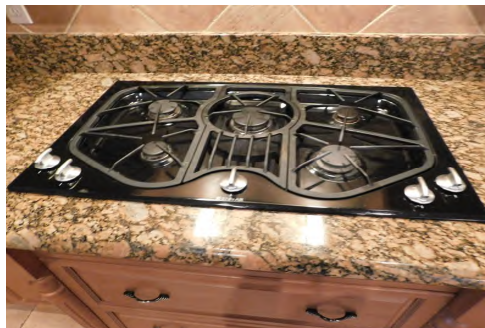
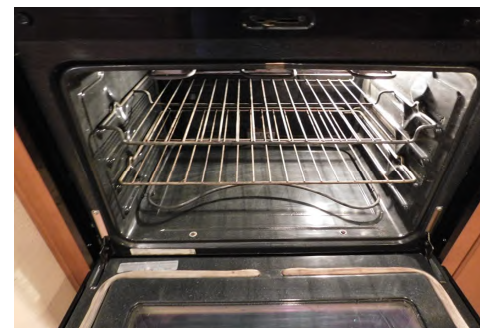
Range/Oven

Limited inspection. Gas was not on. Noted: Double ovens are functional.

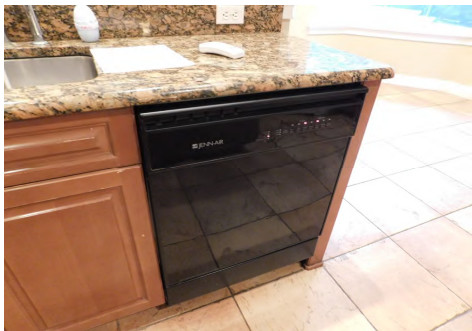
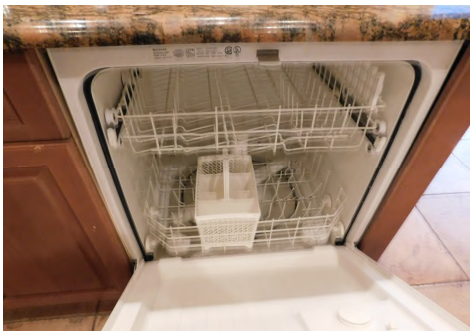
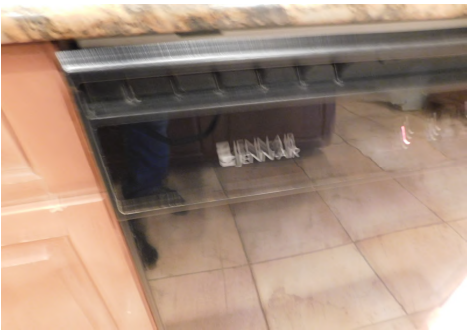
No concerns observed.

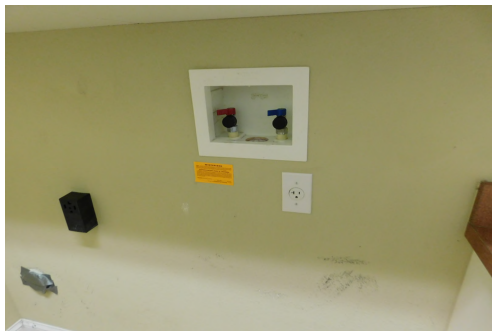
Washing machine

Absent / None

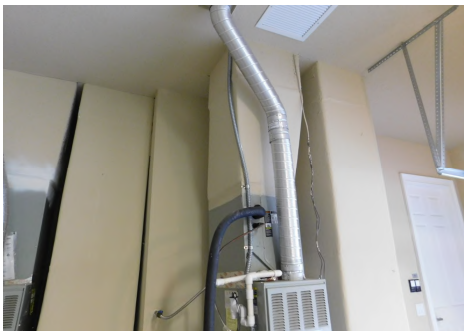
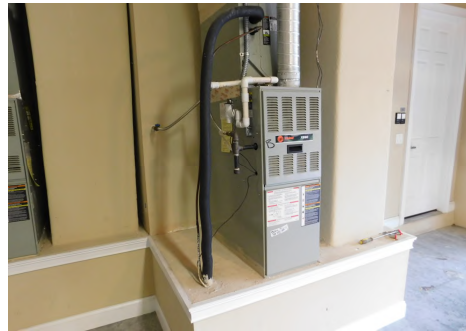
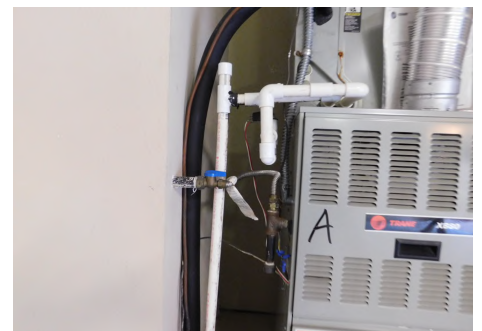
Gas was not on. Heat was not inspected.

Further Inspection is recommended

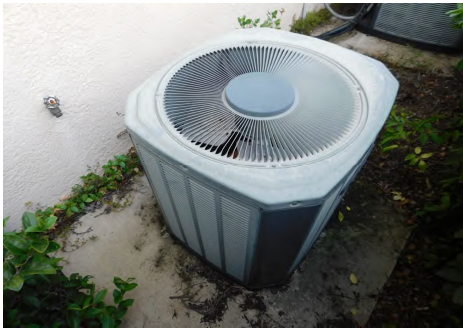
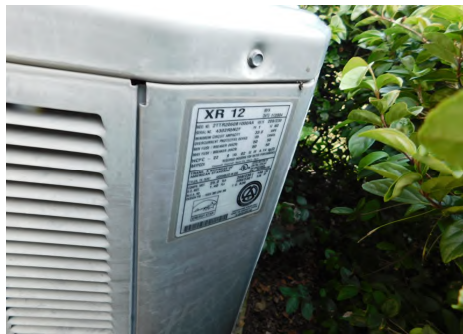
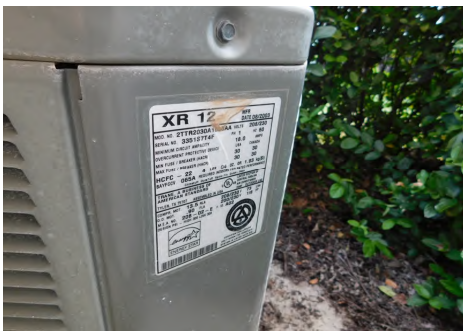
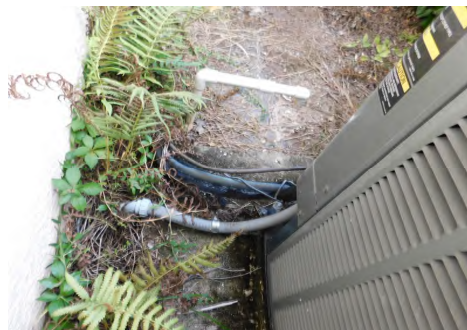
Correction Needed		Qualified Professional Needed			
System Name	Trane	Year Model	2004 x 2		
Compressor		Compressor:			
System Name	Trane	Year Model Air	2003 and		
Air Handler:		Handler:	2004		
Cooling type:	Central Split Air Conditioning System	# of zones	2	Location:	Yard
Temperature at Return:	71	Temperature at Register	53	A/C Differential Sufficient	Yes
Filter:	Replace	Thermostat:	Secure	Suction Line Insulation:	Not sufficient

Condenser lines need new insulation. Both units need to be serviced. Upstairs unit needs repairing - Inspector got the unit to turn on briefly- drain sensor was turning the unit off. Drains need to be cleaned.

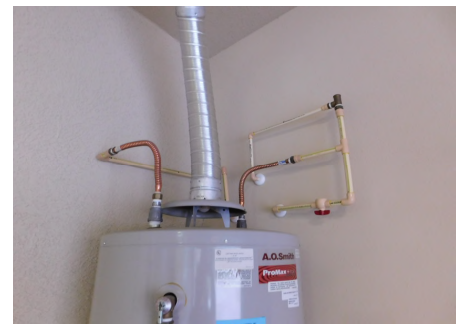
Rusted

Gas was not on at the time of the inspection - Further inspection is needed.

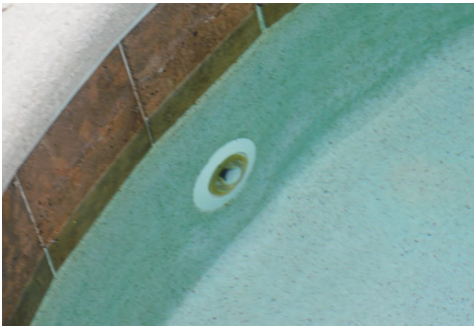
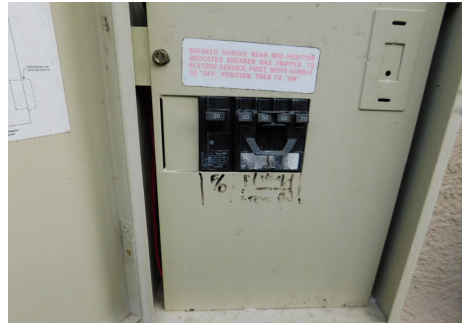
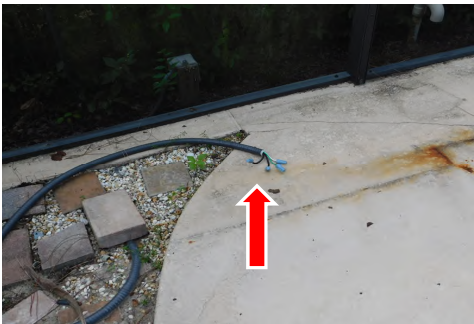
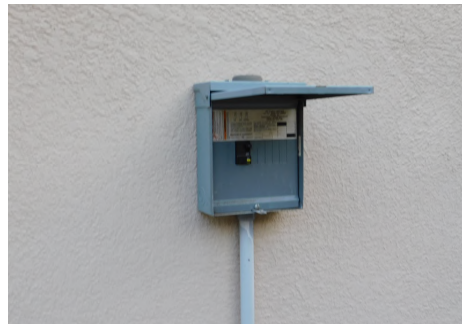
Further Comments: Pool lights are not functional. Lights need to be on a GFCI. Exposed wiring in the pool area - repair. Automatic Chlorinator needs replacing.

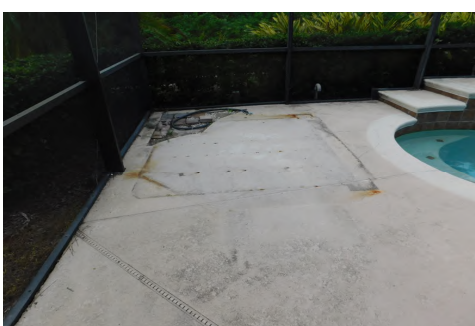
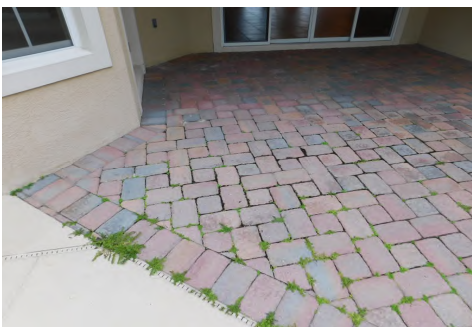
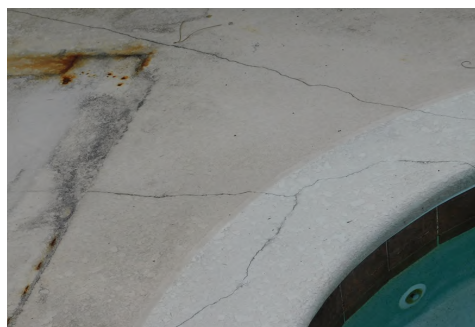
Further Comments: Exterior concrete decking settling cracks noted . Interior pool stains noted. Paver maintenance is needed.

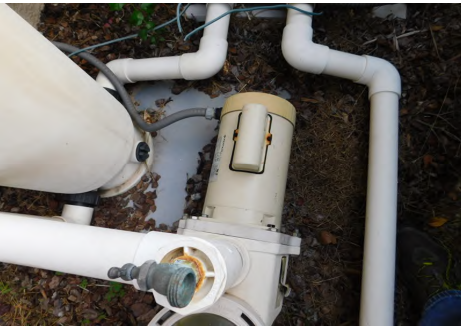
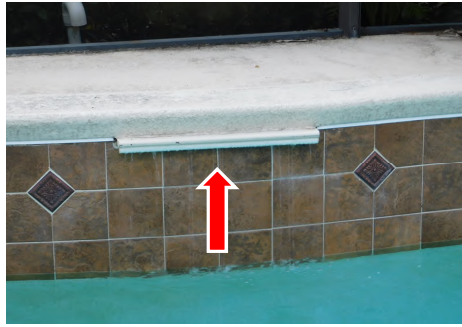
Further Comments: 1- Rain jet needs repairing.

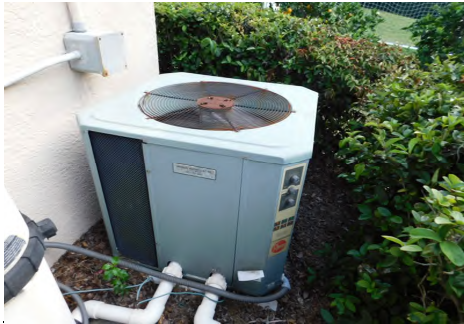
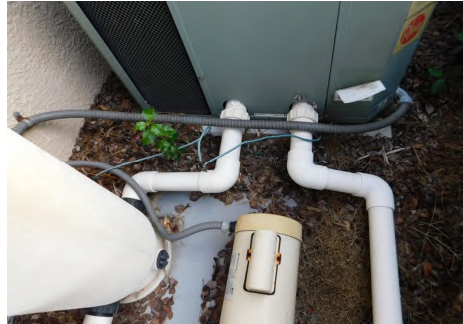
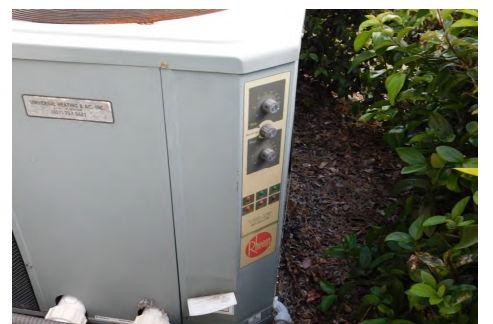
Pool / Spa Heating System(s)

Further Comments: Heater is functional but not heating the water.

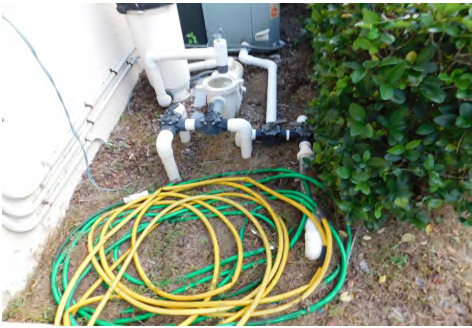
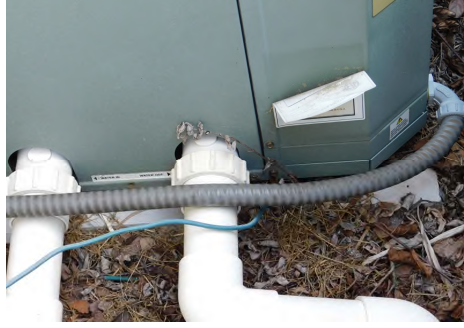
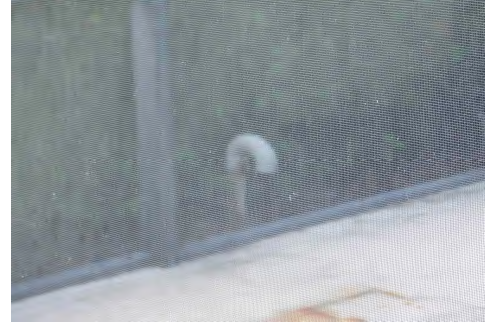
Material: PVC piping

Further Comments: No major concerns observed.

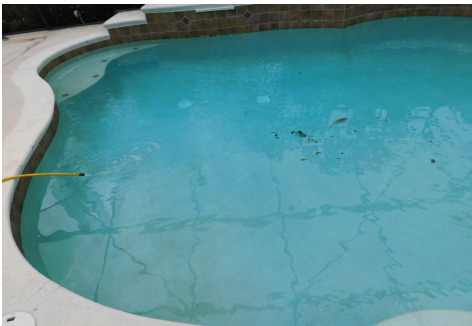
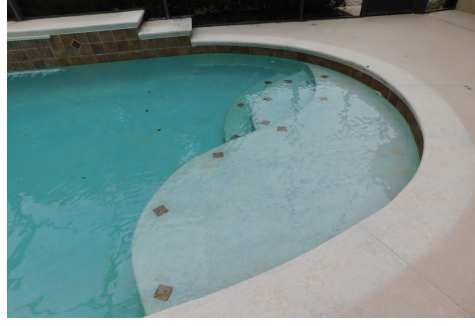
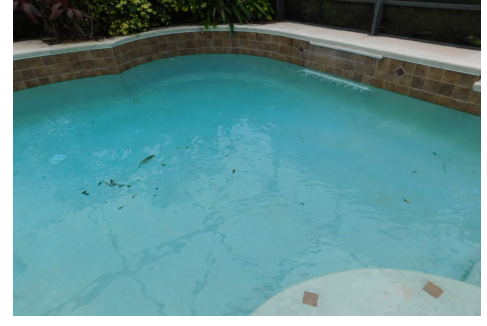
Water Condition

Water condition: Clear

Water level at the time of inspection Normal/ Low

Further Comments: No concerns observed.

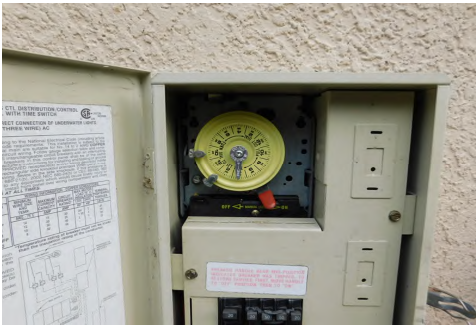
Type: Single enclosure unit (240 volt)

Further Comments: No concerns observed.
