ALL IN ONE INSPECTIONS

*** Residential Inspection Report ***

123 Main Street
Orlando , FL 32222

Date Of Inspection: March 26, 2014

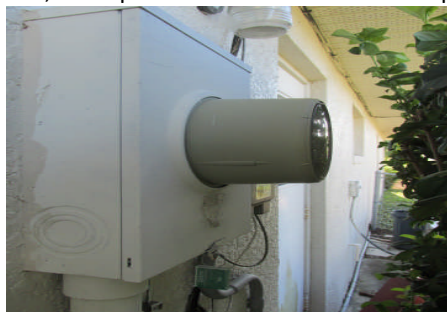
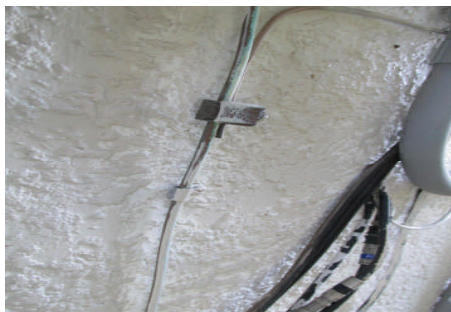
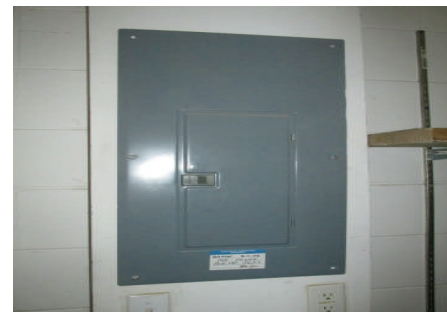
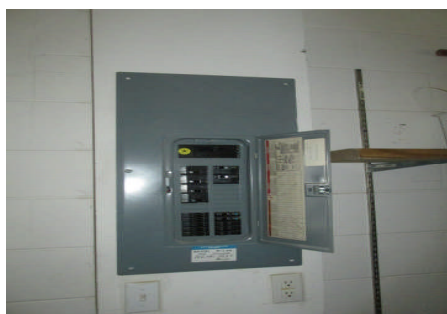
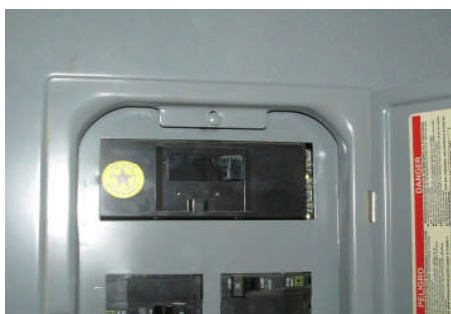
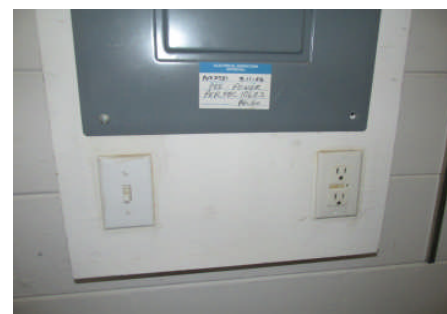
Noted; Main panel needs two screws on top.

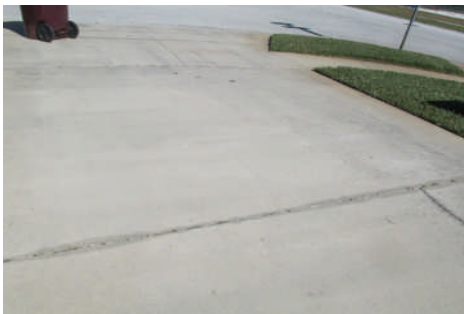
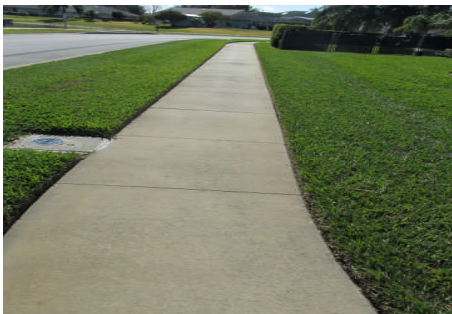
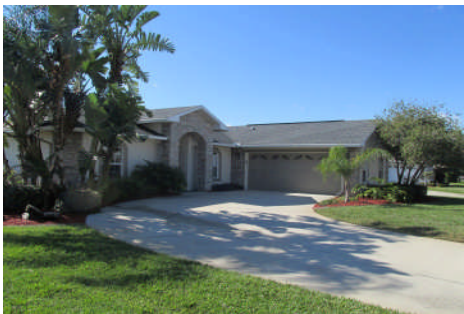
Material: Concrete
Further Comments: Stress cracks noted.

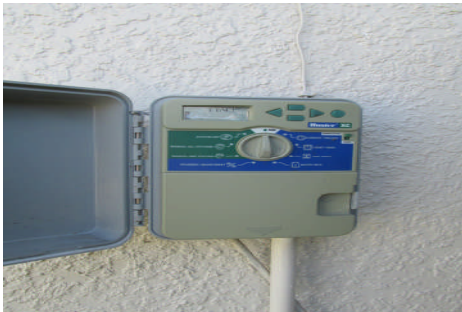
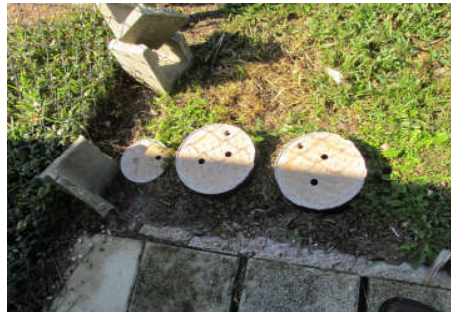
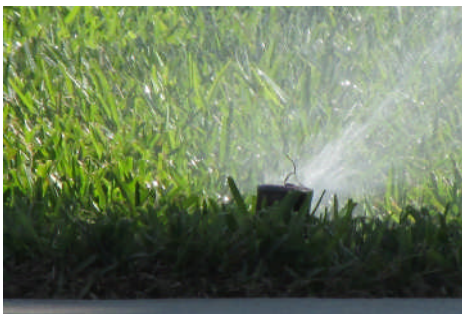
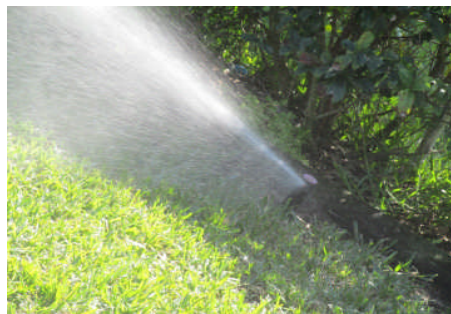
Correction Needed			Repair Needed		
Type:	Automatic	Water Source:	Public Utilities (Underground Service)	Number of Zones	# 5
Any Leaks	No	Sprinkler Heads:	4+ Heads need adjusting.	Vacuum Breaker	Yes
Timer:	Functional	Coverage:	Sufficient

Further Comments: Maintenance needed on all heads.

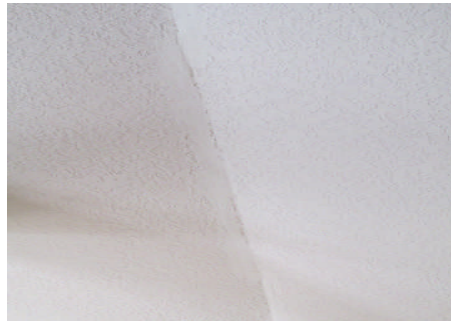
Further Comments: Seam on ceiling in family room was repaired. Need minor sealing.

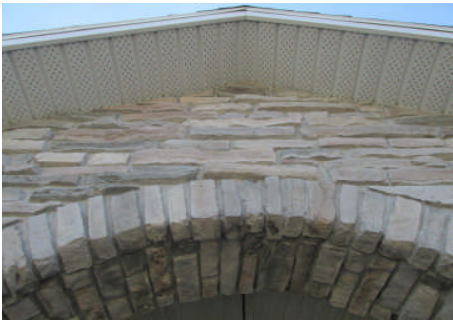
Material: Stucco and stone
Further Comments: Reseal stucco cracks

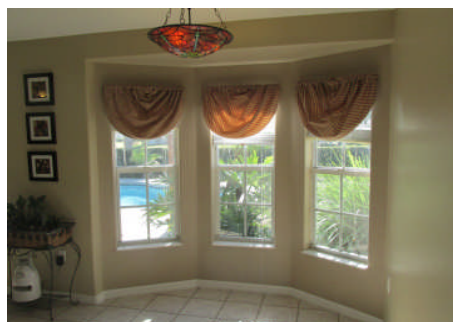
Further Comments: Windows on the interior and exterior need resealing. One marble sill is damaged.

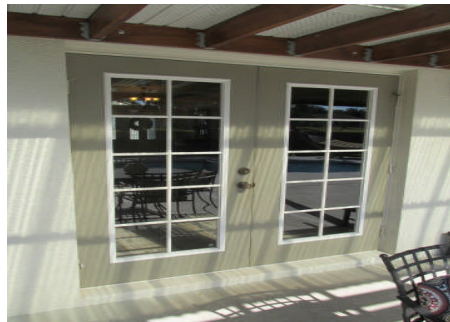
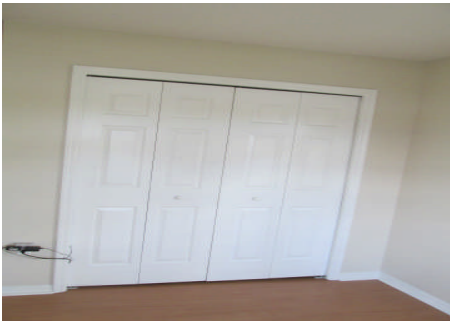
Further Comments: French doors hinges need to be secured. Side pedestrian door has rot on bottom of door and frame.

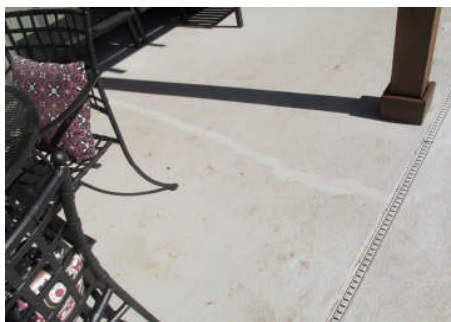
Further Comments: Stress crack noted.

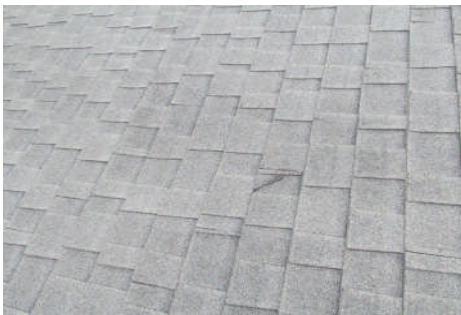
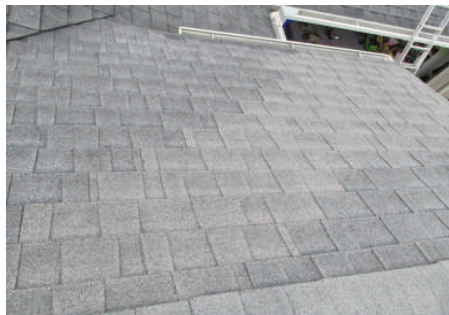
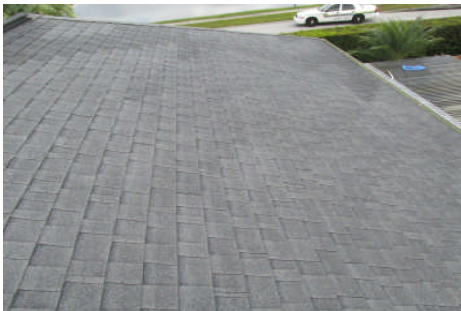
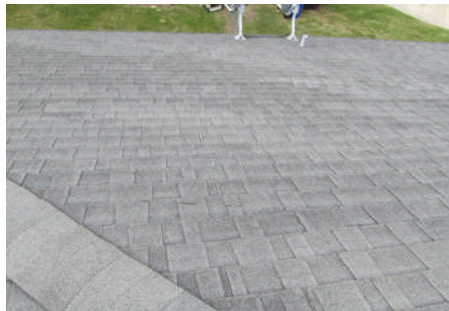
Further Comments: Patched area noted on ridge caps.

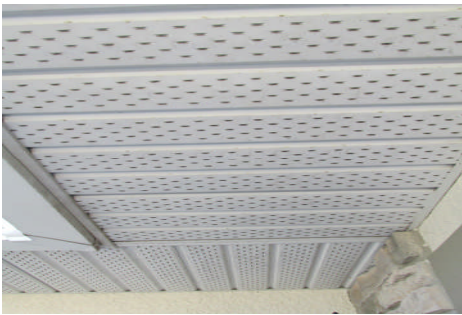
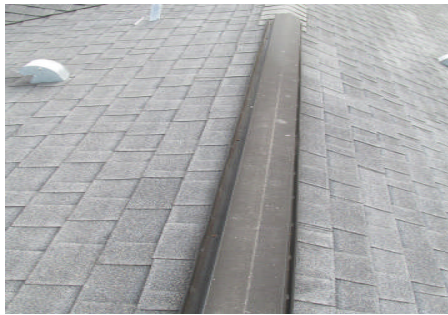
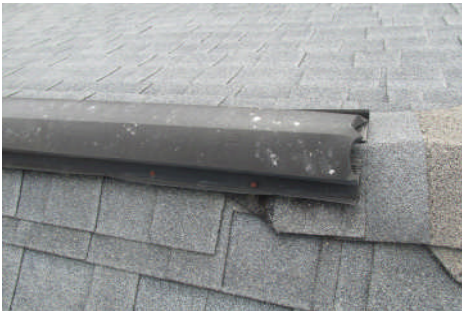
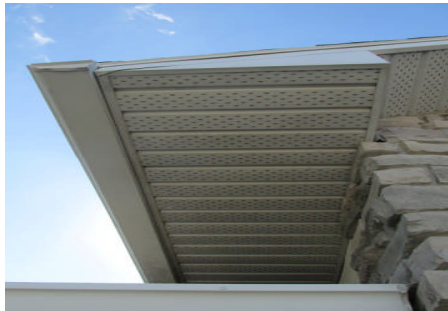
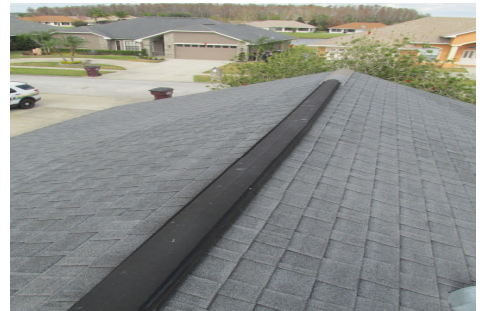
Further Comments: Ridge vent needs to be secured and sealed. Nails coming up.

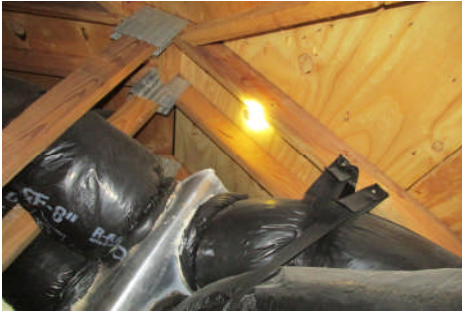
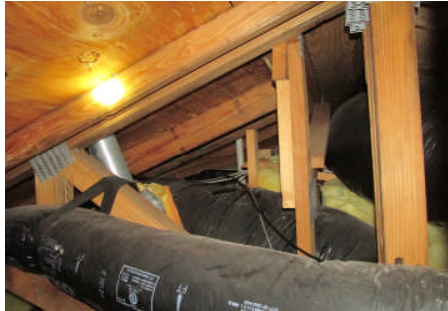
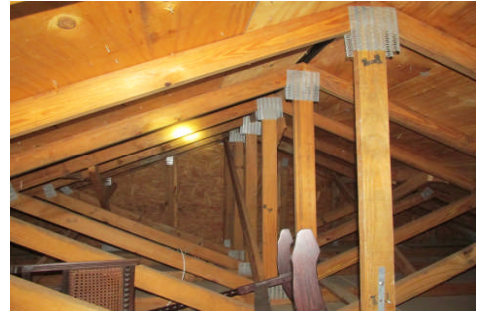
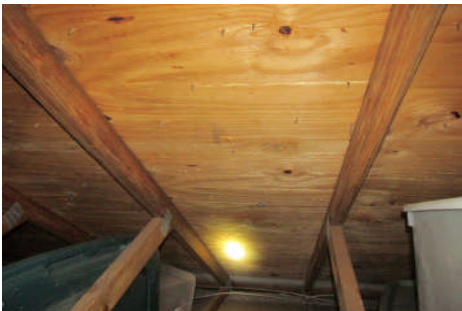
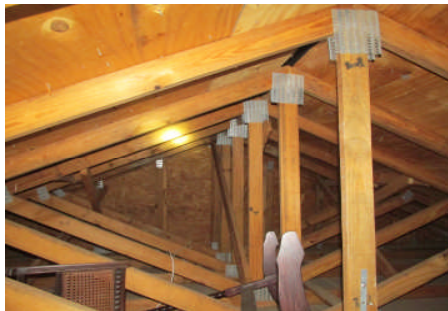
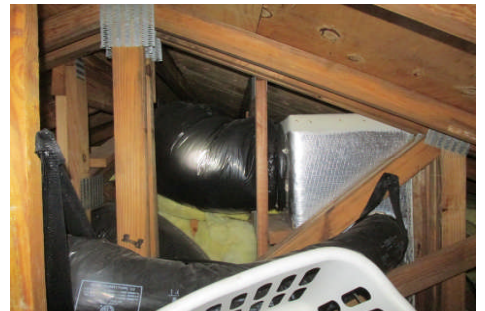
Viewed From: By entering crawl space Access: Pull-down and hatch
Vent Screens Adequate % of Attic Inspected: 40
Further Comments: Limited access due to vents and trusses

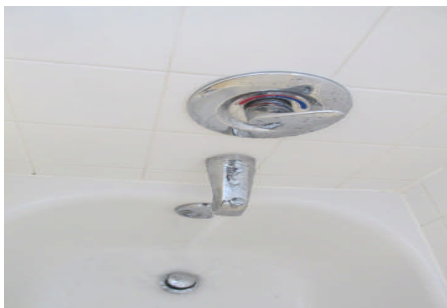
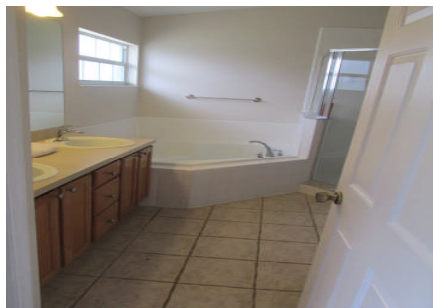
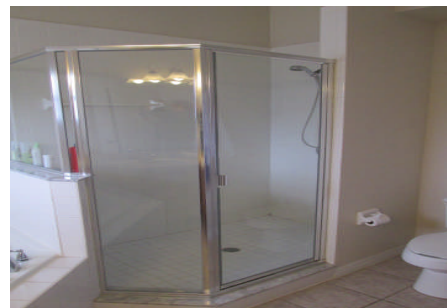
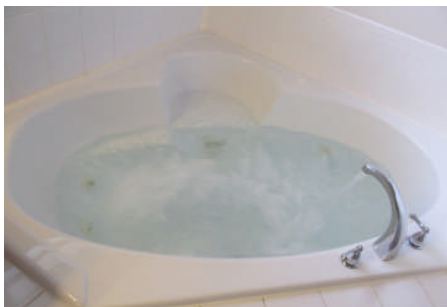
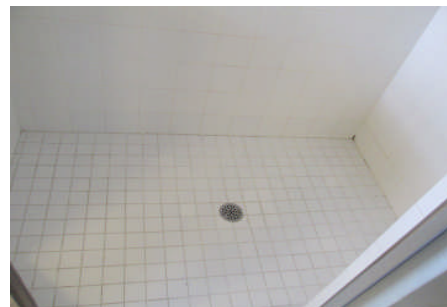
Further Comments: Tub and shower surrounds need to be sealed. Tub diverter needs repairing.

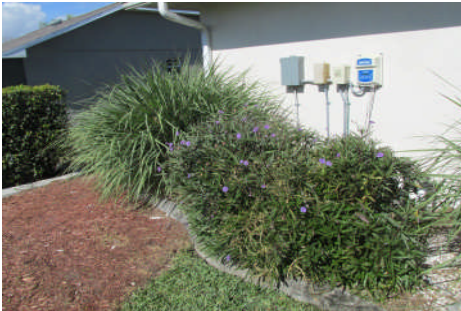
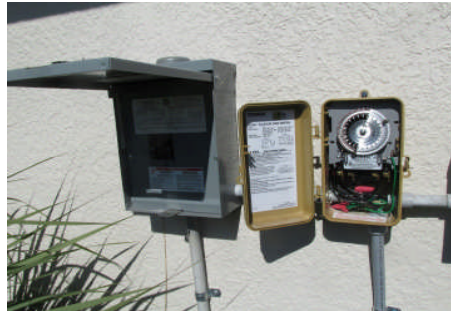
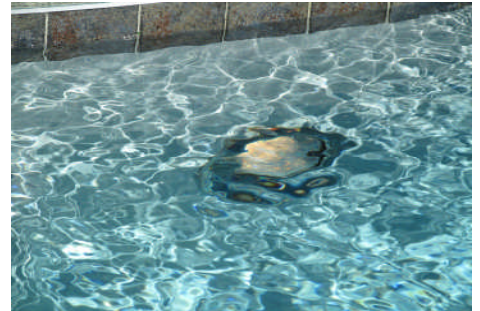
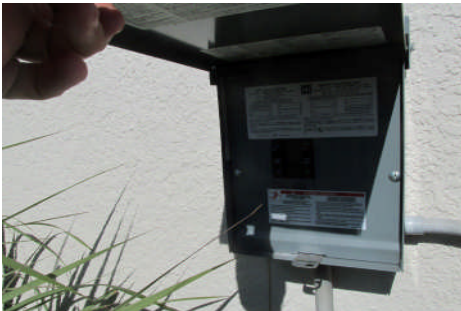
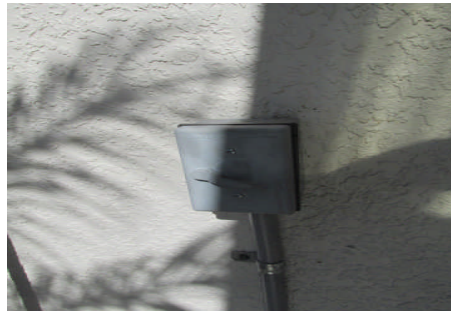
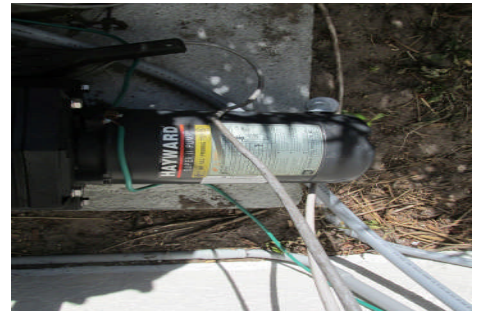
Further Comments: No concerns noted

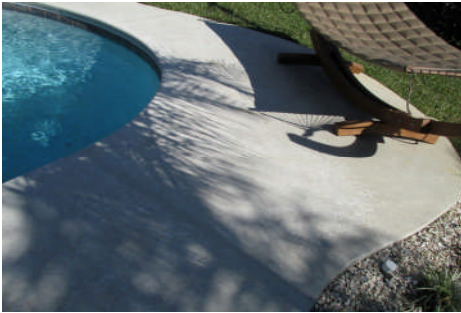
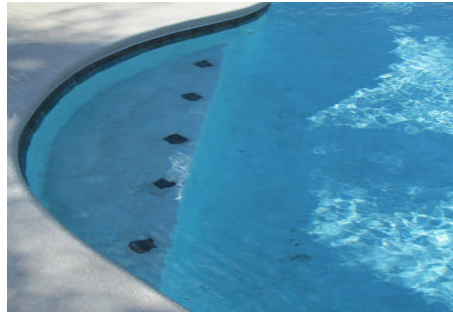
Structure Condition, Decking and Coping

Further Comments: Stains on interior of walls and floor of the pool.

Recommend Maintenance

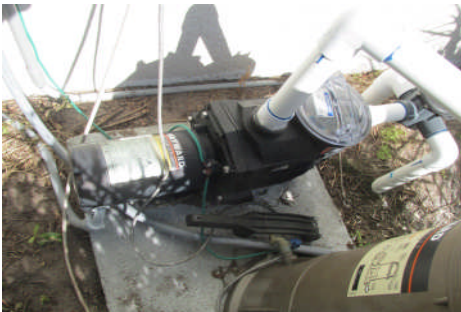
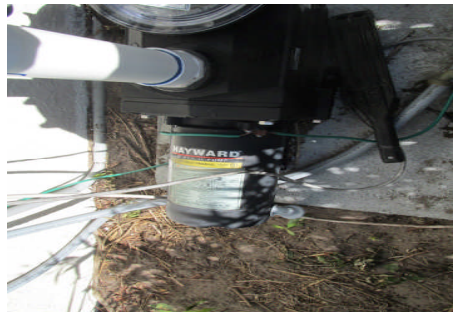
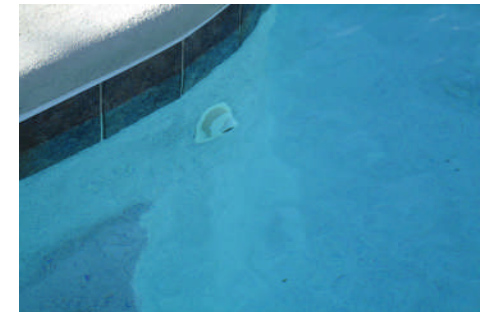
Pump(s) / Jets

Further Comments: No concerns observed

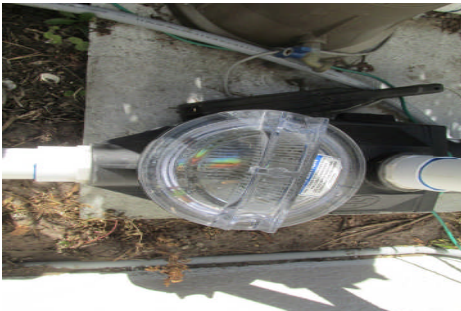
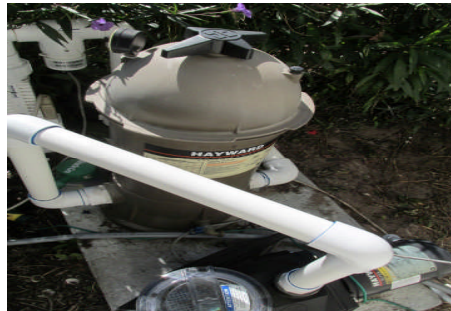
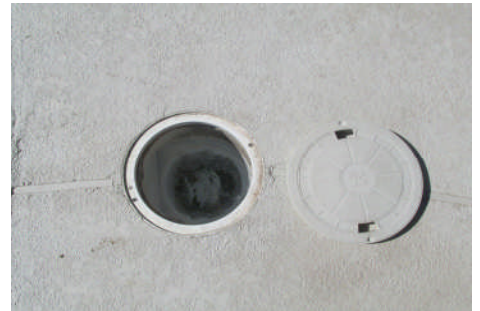
Further Comments: No concerns observed

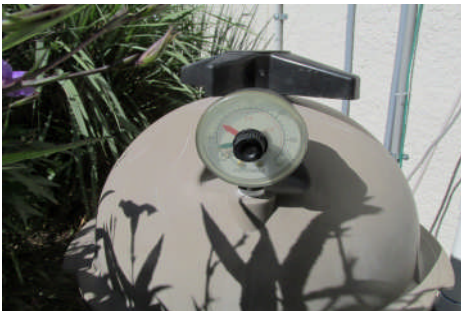
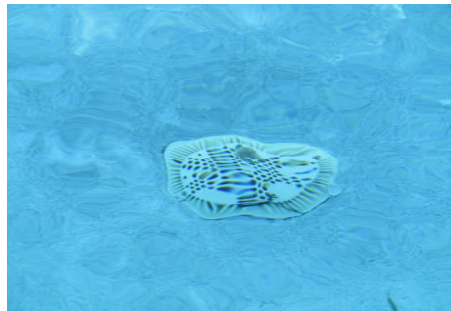
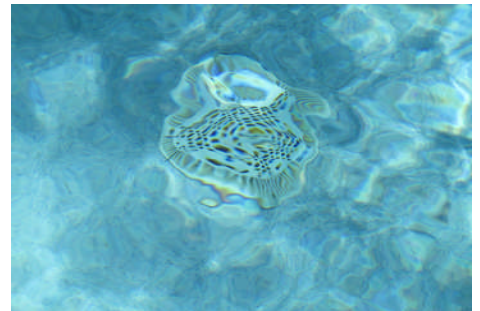
Pressure Gauge/ Drain covers

Further Comments: No concerns observed

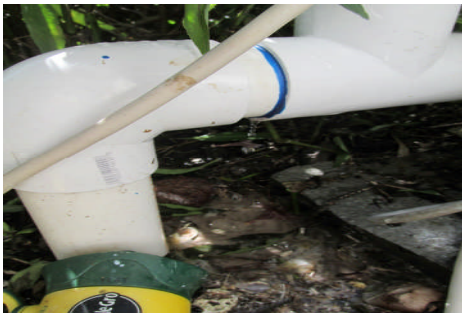
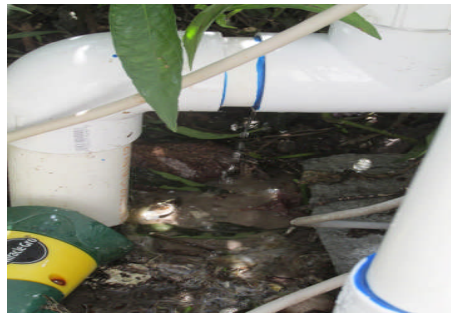
Further Comments: Leak in PVC piping next to pump.

Repair Needed

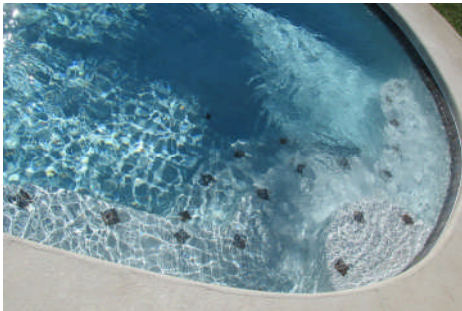
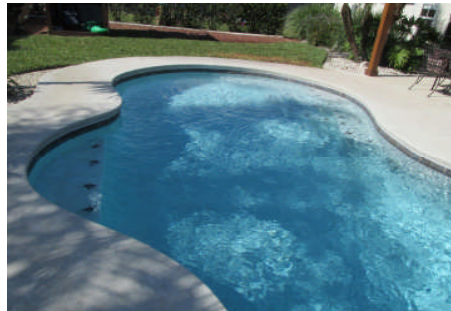
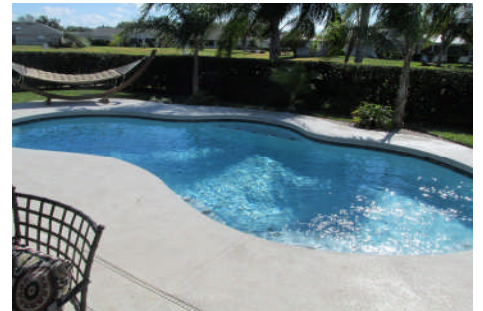
Water Condition

Water condition: Clear

Water level at the time of inspection Normal

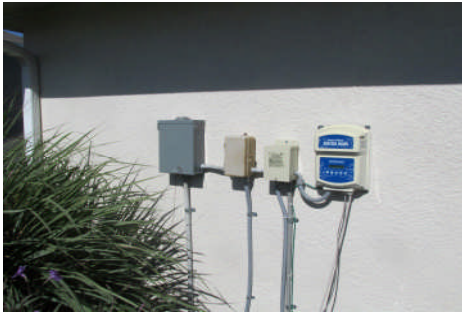
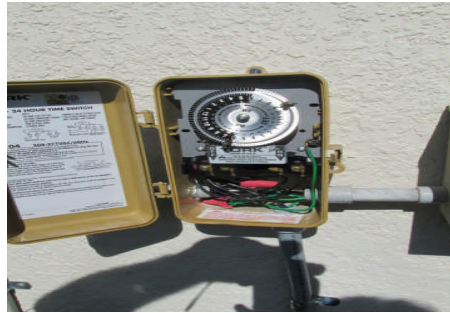
Further Comments: No concerns observed
